CYCLONE TESTING STATION

## **REPORT NO. TS868**

# Simulated Windborne Debris Impact Testing of Astroguard Impact Protection Screen Assembly System

# **Cyclone Protection Australia**

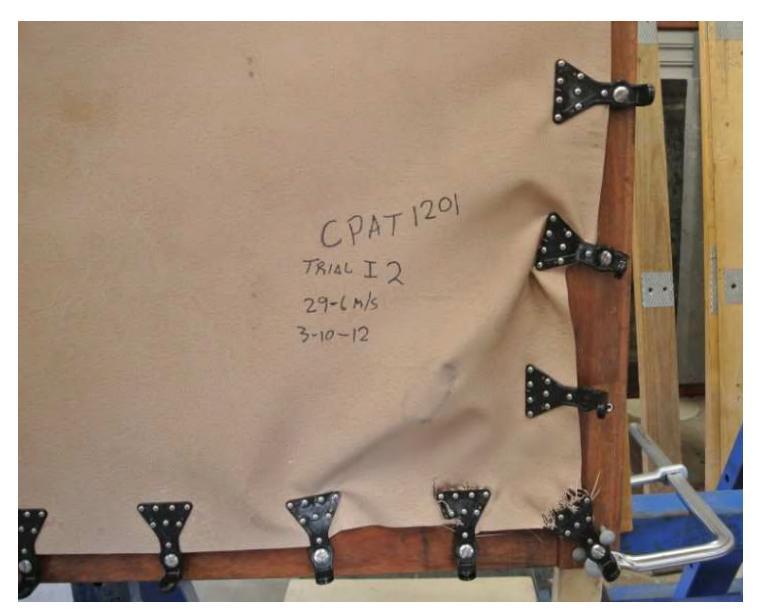
Test No.	Date Tested	Impact Location	Measured Impact Velocity (m/s)	Results and Observations
1	3 Oct 2012	Corner	29.6	<b>Pass</b> . No penetration. Tearing of fabric around one clip. Another clip pulled out.
2		Geometric centre	28.6	<b>Pass</b> . No penetration. One screw started to pull out.
5	9 Oct 2012	Various (five in total)	34.2, 32.9, 31.2, 34.2, 31.1	<b>Pass</b> . No penetration and no visible damage.

Figure 8: General view of damage after Test 1 (Note: Test 1 was labelled "Trial I2" during testing)

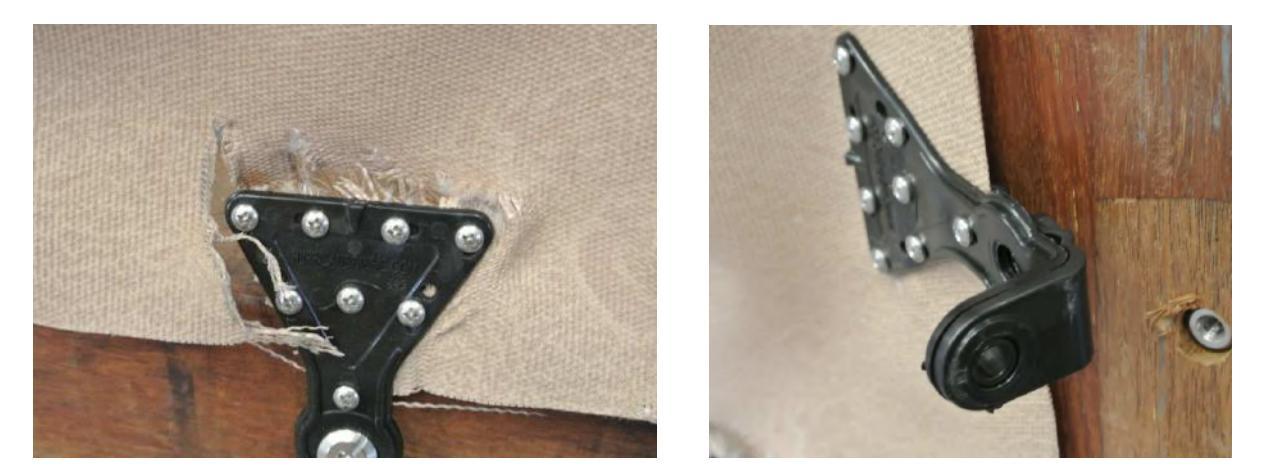
Figure 9: Tearing of fabric around a clip (left) and one clip pulled out (right) after Test 1

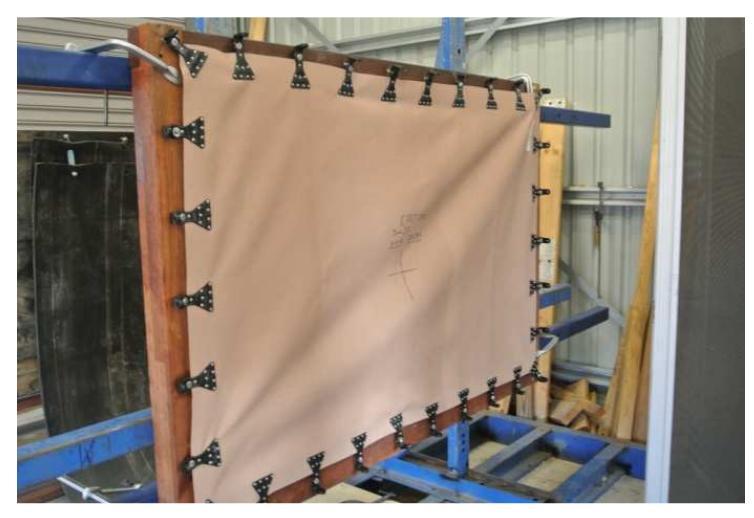
Figure 10: No penetration after Test 2

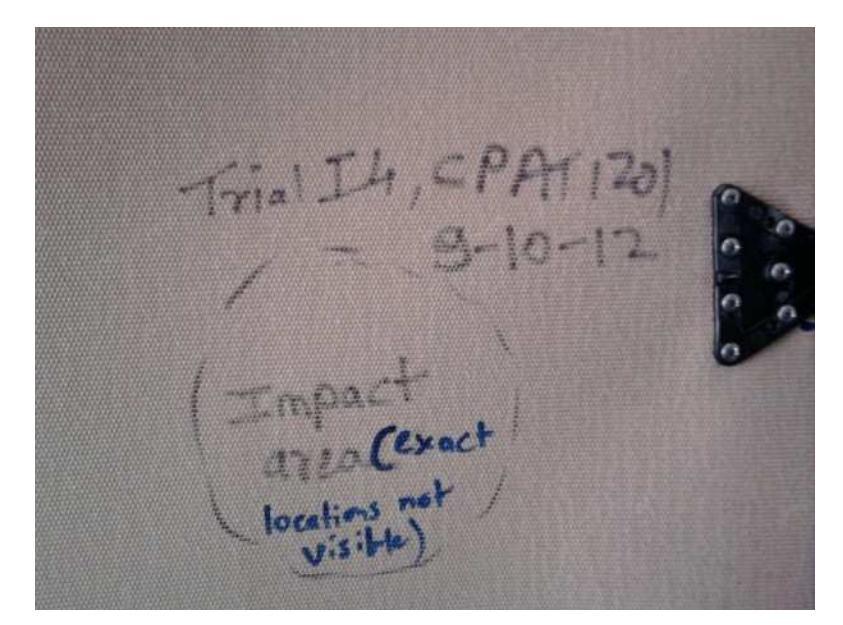
Figure 11: Impact location for Test 3 (Note: Test 3 was labelled "Trial I4" during testing)
