# AstroGuard and Cyclone Winston Performance report

Cyclone Protection Australia

# Review of 2 properties protected by AstroGuard during Tropical Cyclone Winston

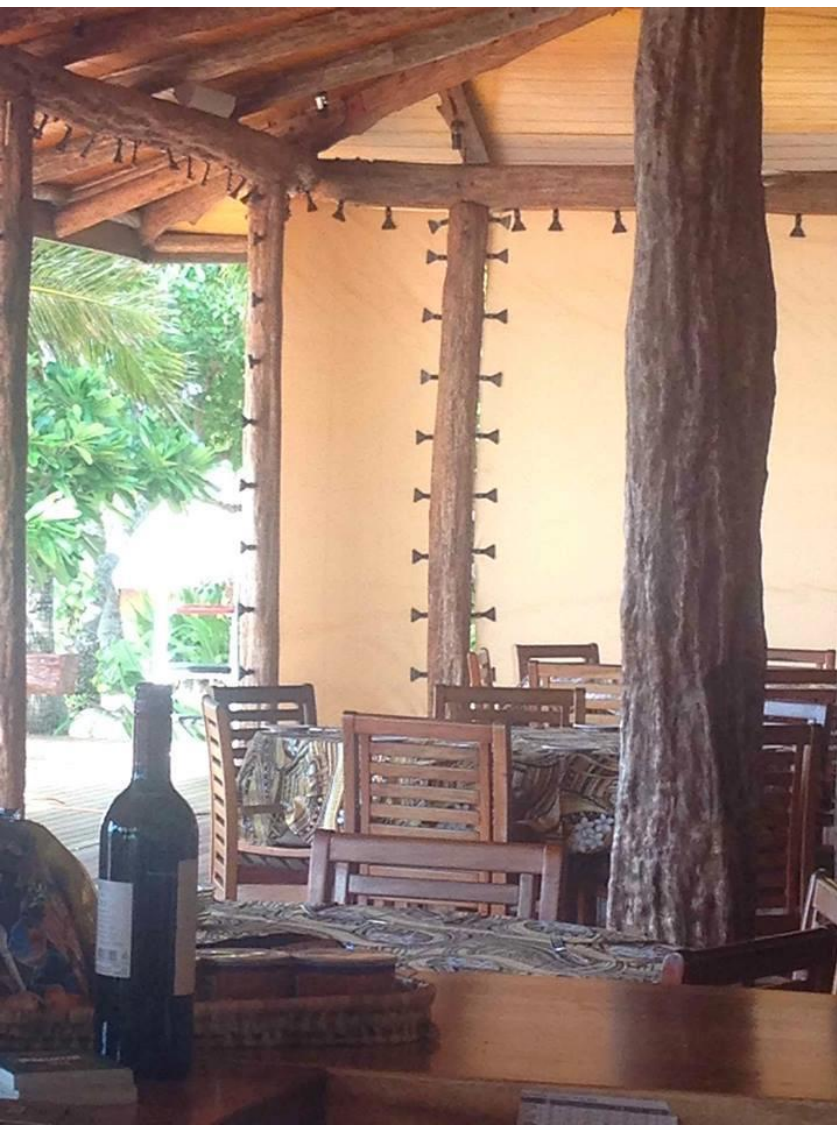
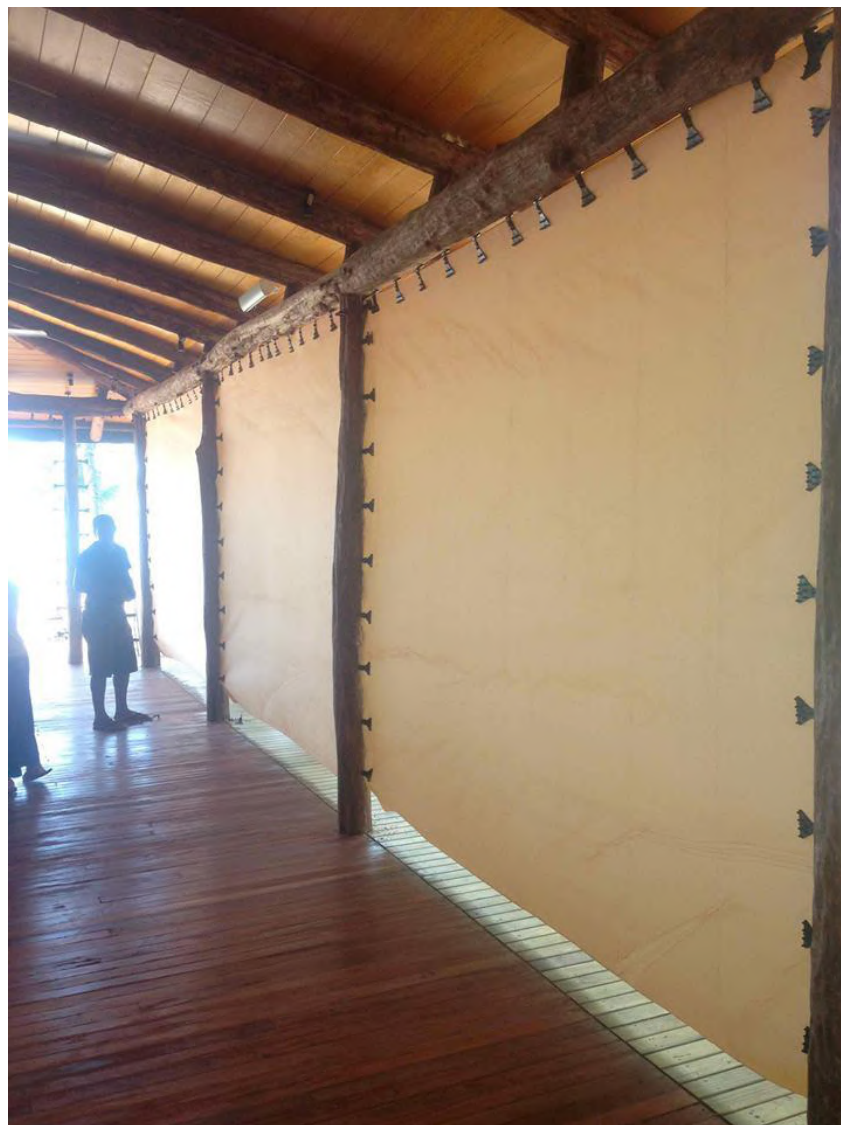
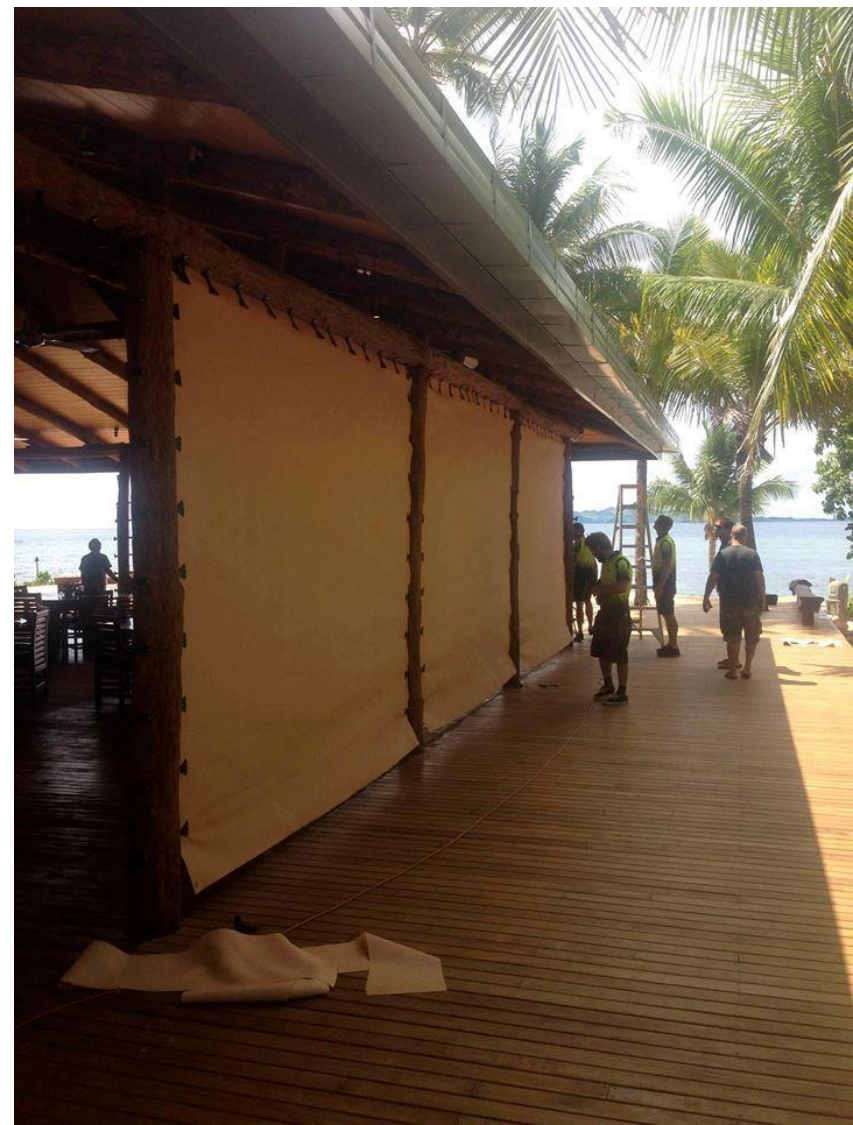
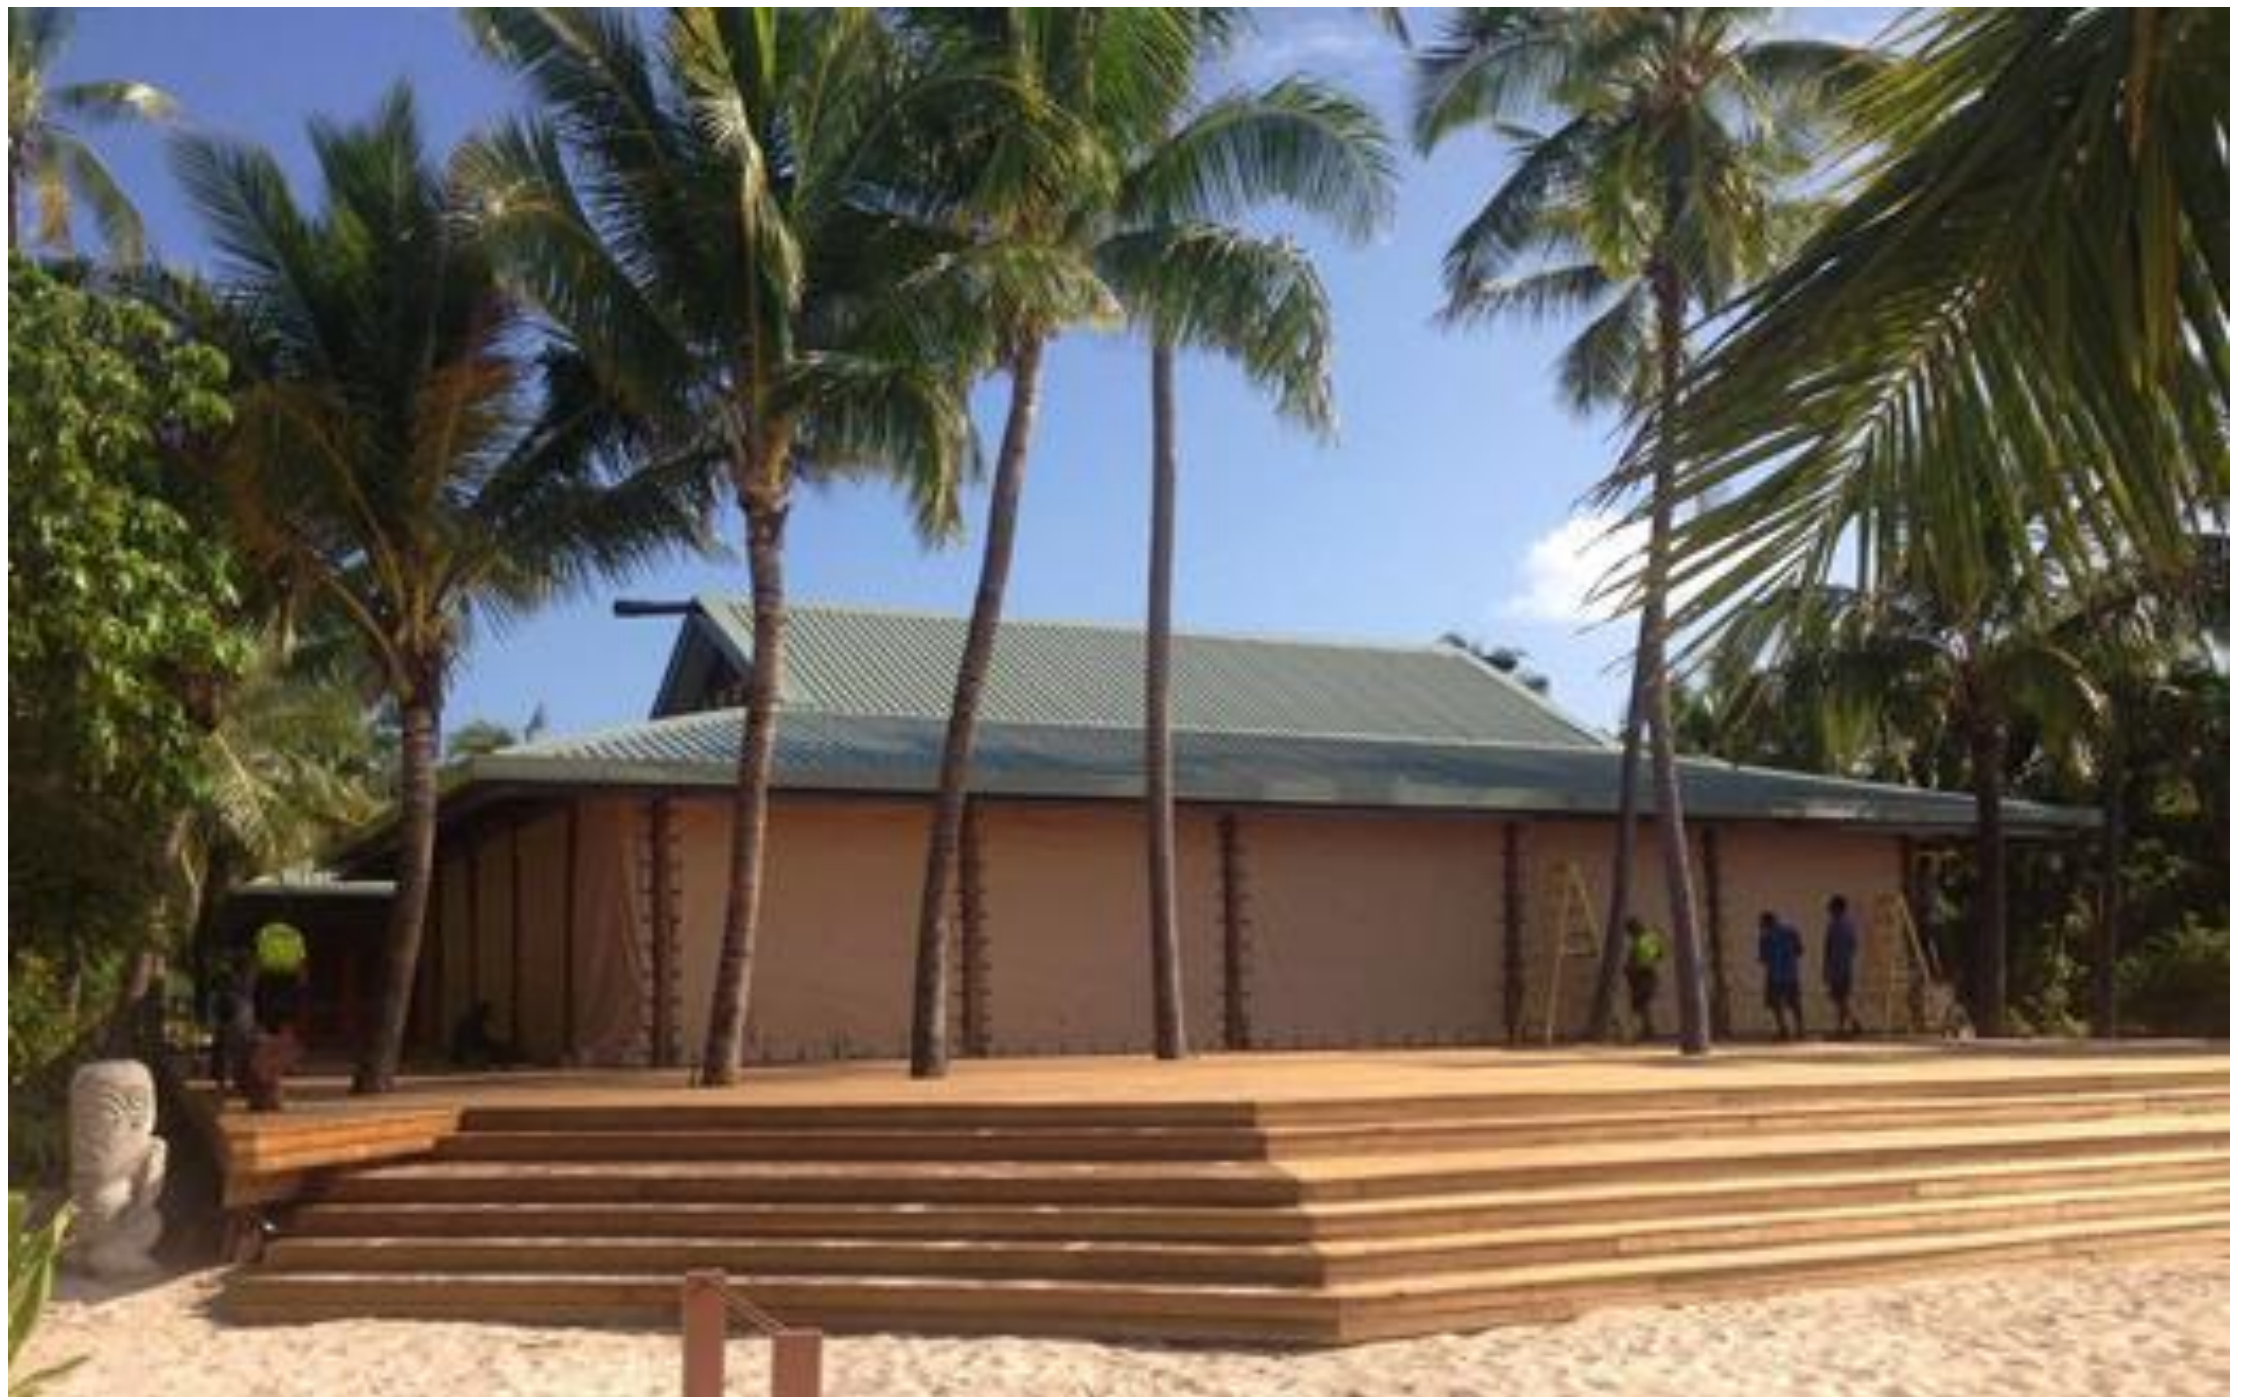
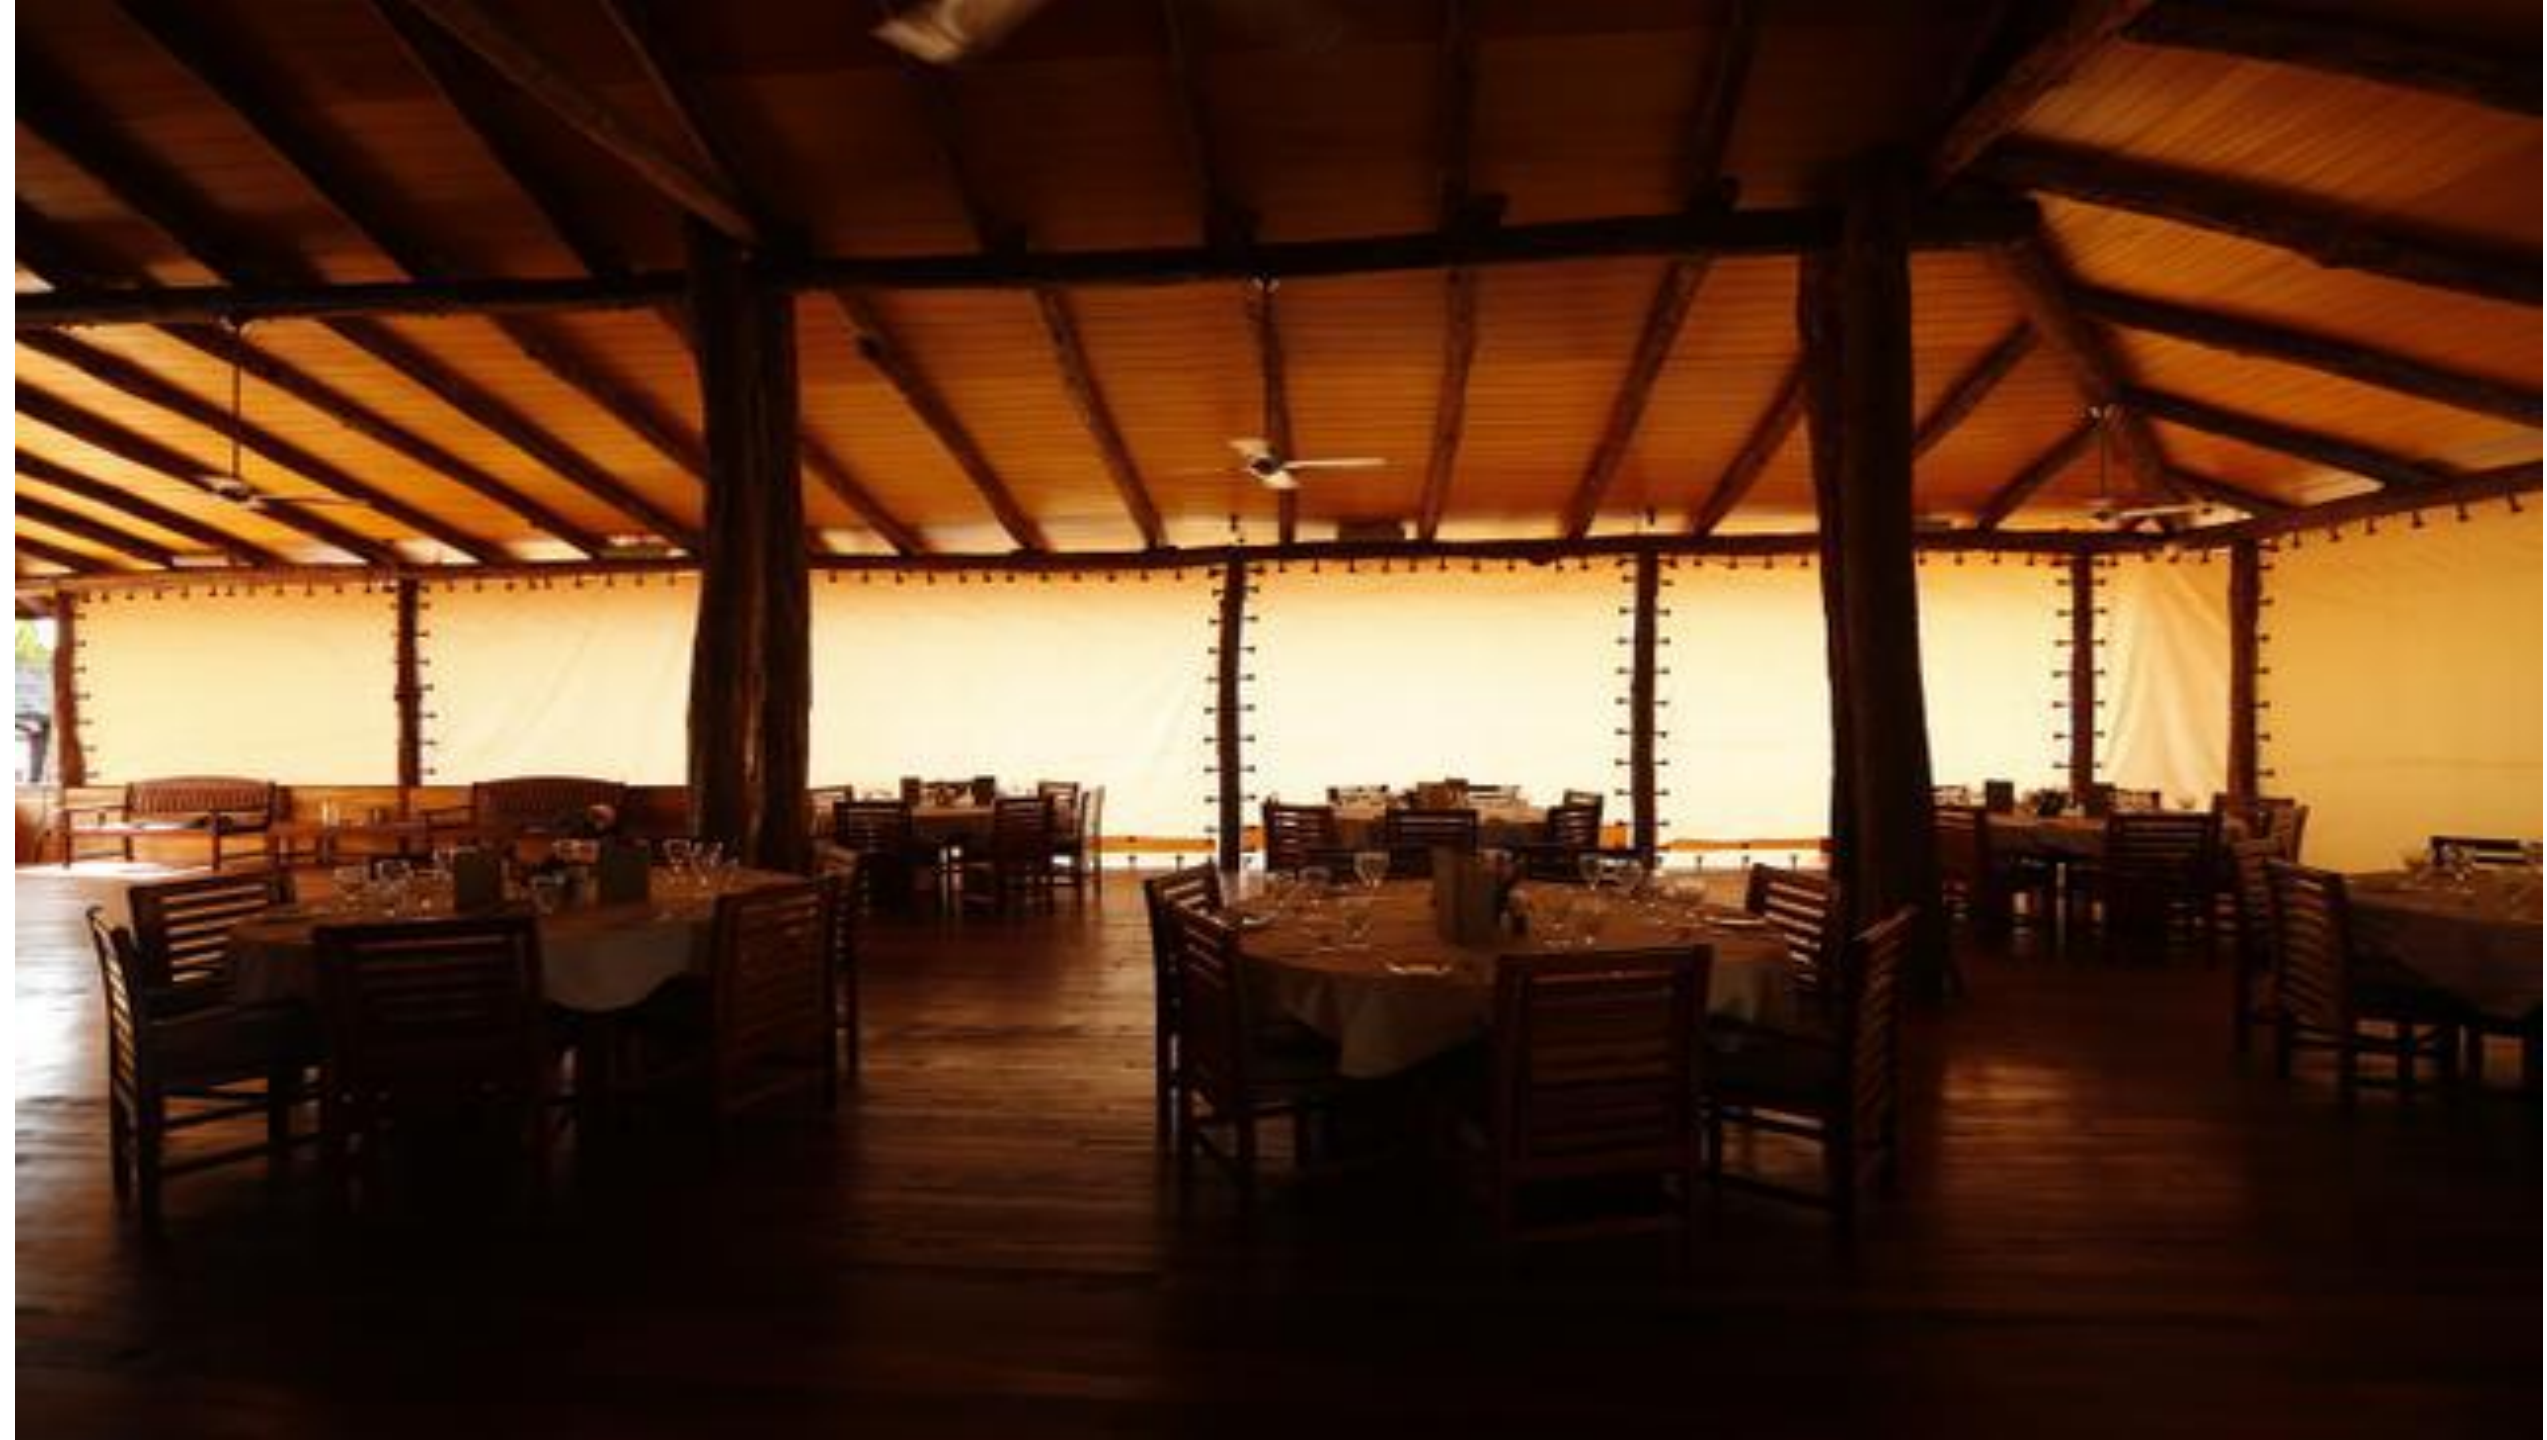
- Directly in the path of Winston – took the full brunt
- Large sheets attached between uneven timber around restaurant and bar area
  - Protection against wind load
  - Protection against flying debris
  - Protection against water and sand damage
- “Unique properties and versatility of AstroGuard system make this the only viable solution for this structure”
  - Rick Isbell – co owner

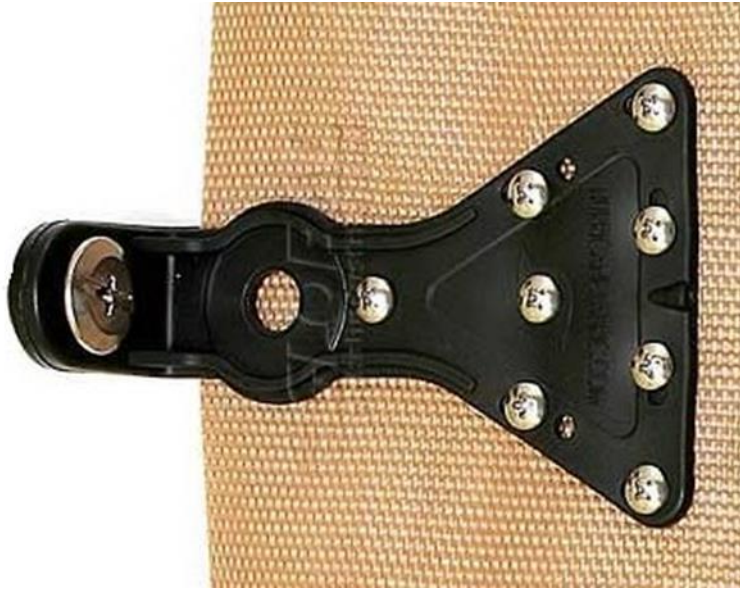
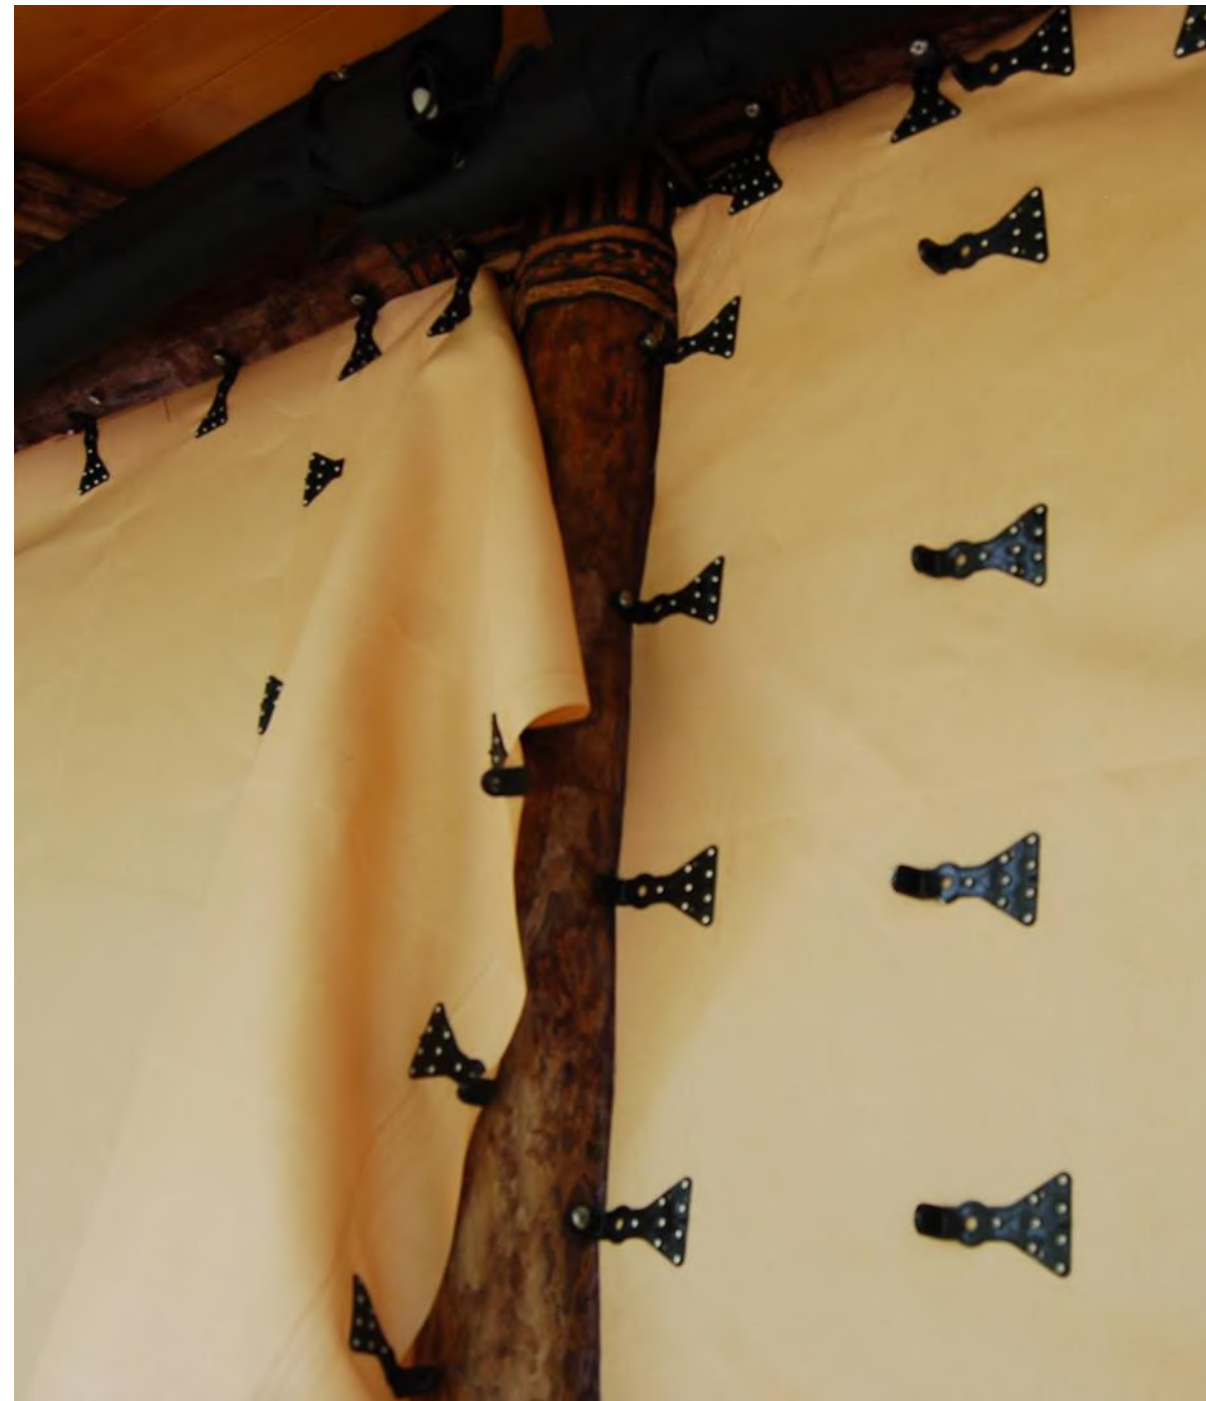
Clips attached to structure primarily by the “foot plate” of the clips because of the uneven surface of the timber columns

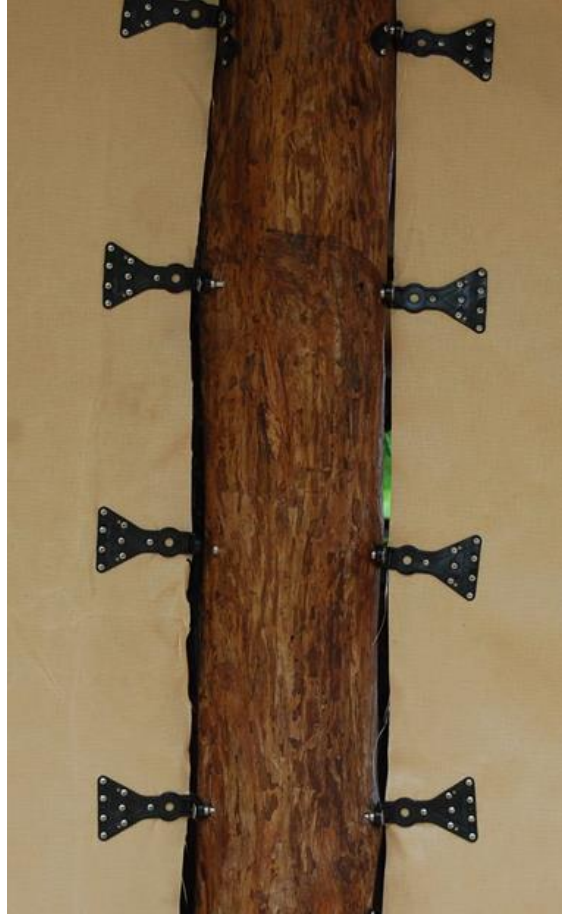
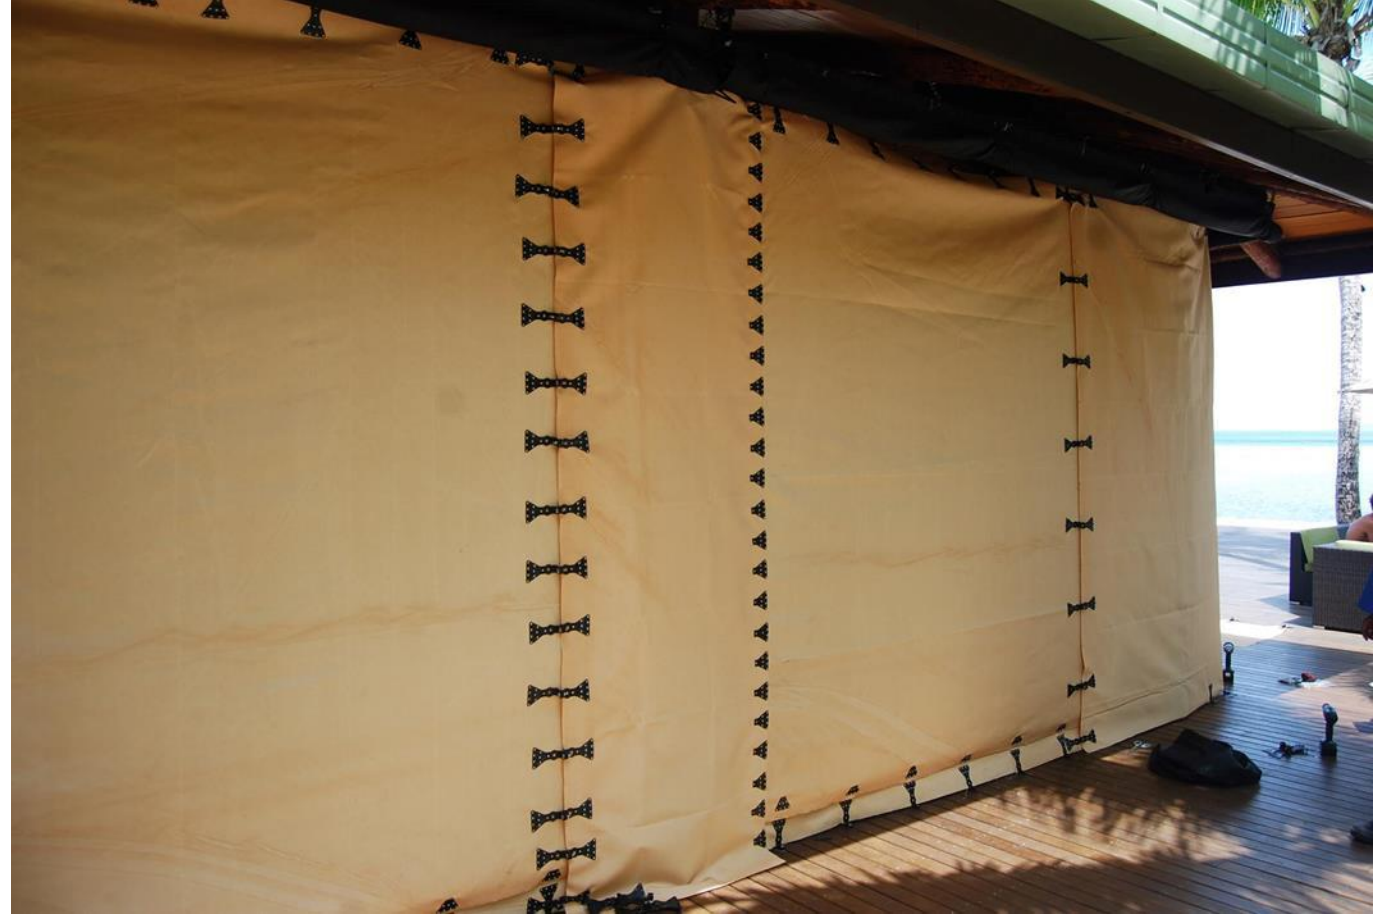
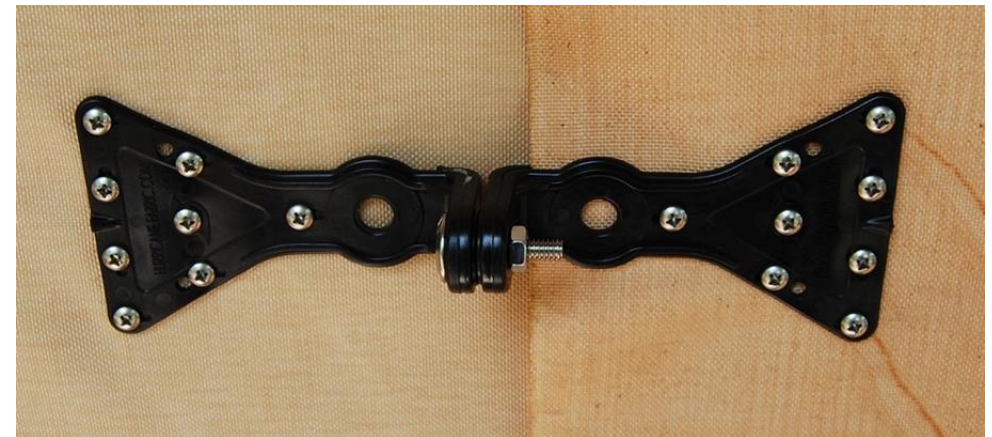
- Additional sections of fabric 'welded' on with modified clips to close gaps around the columns to minimize sand and water ingress
- This allowed staff to make adjustments from the inside during the cyclone whilst still protected

- Huge forces with reported gusting well in excess of 300 km/hr
- Violent , sustained flapping of sheets lead to rotational forces of the clip foot plate against the head of the anchor bolt

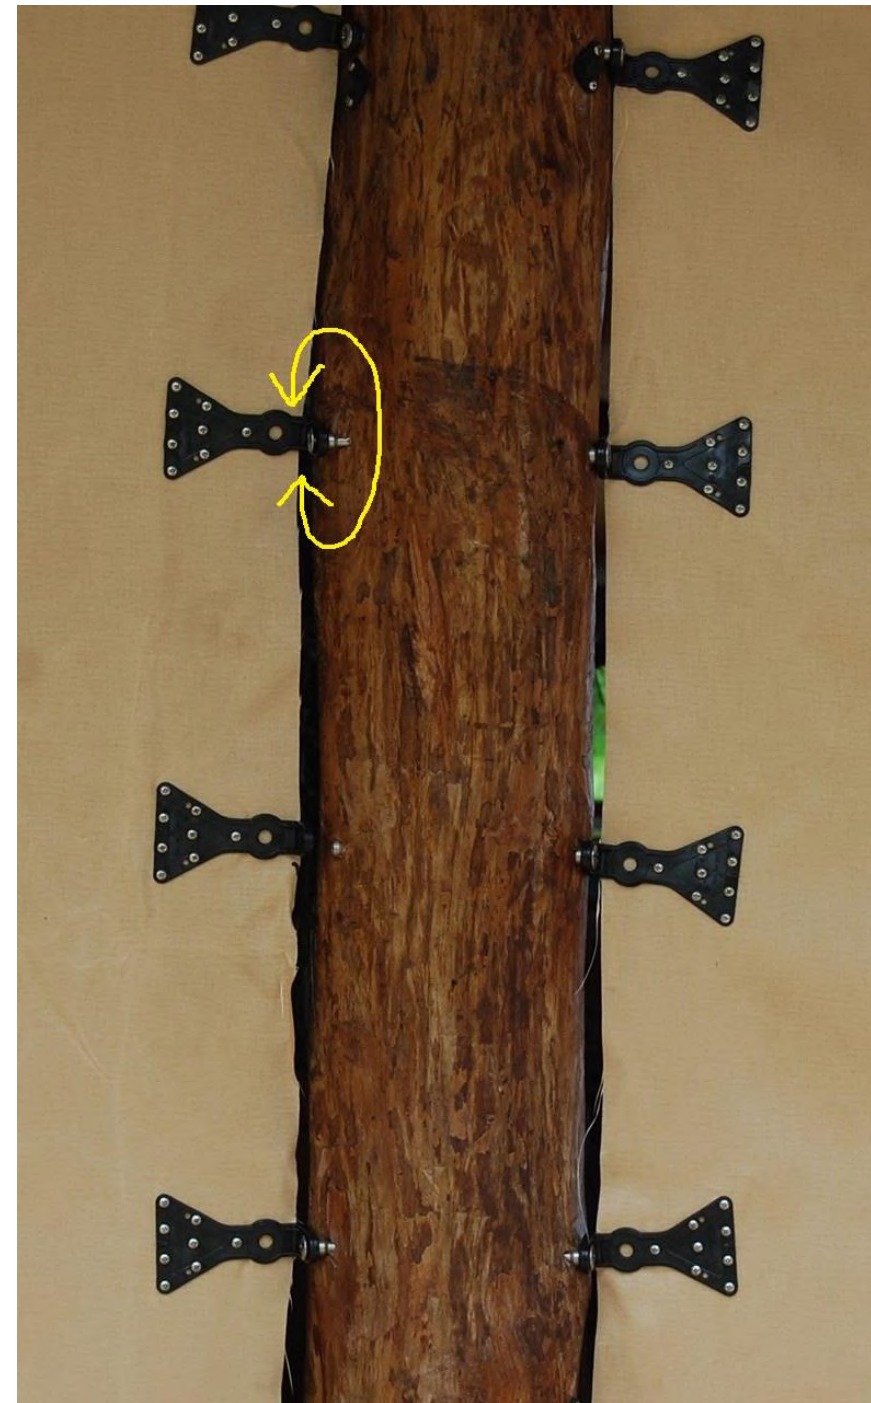
- Ropes wrapped around columns passing through clips as shown was the ideal option
- Can use multiple separate loops of appropriate strength rope / cable
- Cosmetically appealing option for homes/resorts who do not wish to have screws in large wooden trunks

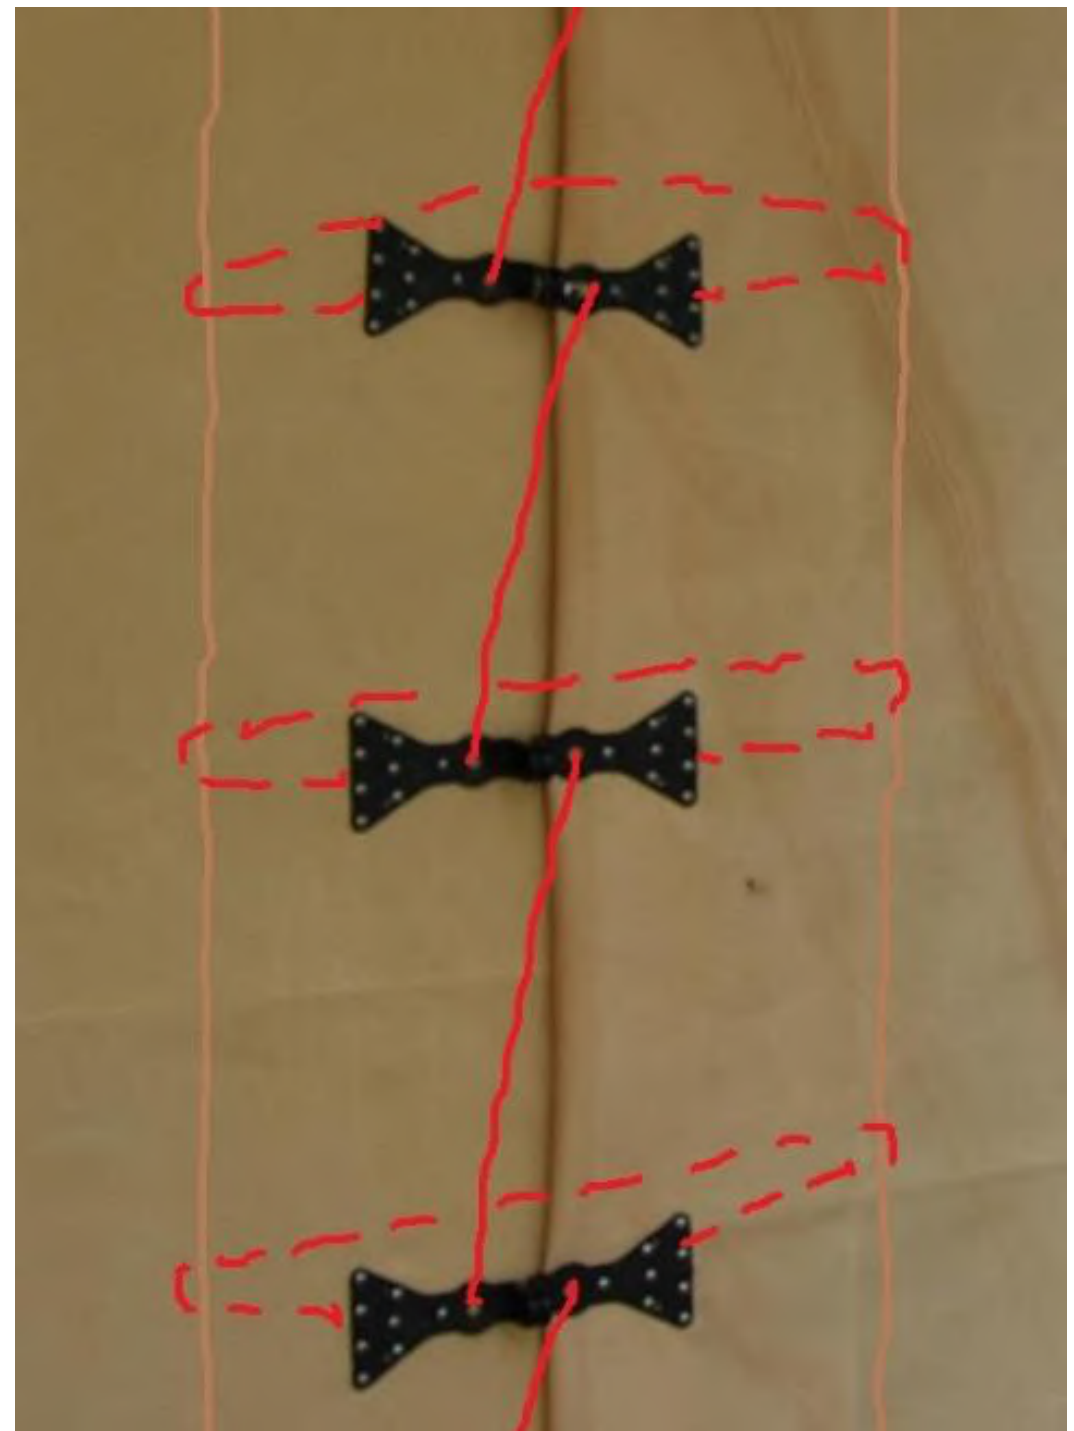
- **The system withstood the full force of Winston and prevented the destruction of the restaurant complex**
- **The complex was functional within days**
- The large sheets of fabric were exposed to enormous forces without damage or tearing
- The clip system worked without any failures
- As the photos show the sheets are in excess of 10 m<sup>2</sup> and withstood sustained winds of 240km/hr and gusts well in excess of 300 km/hr

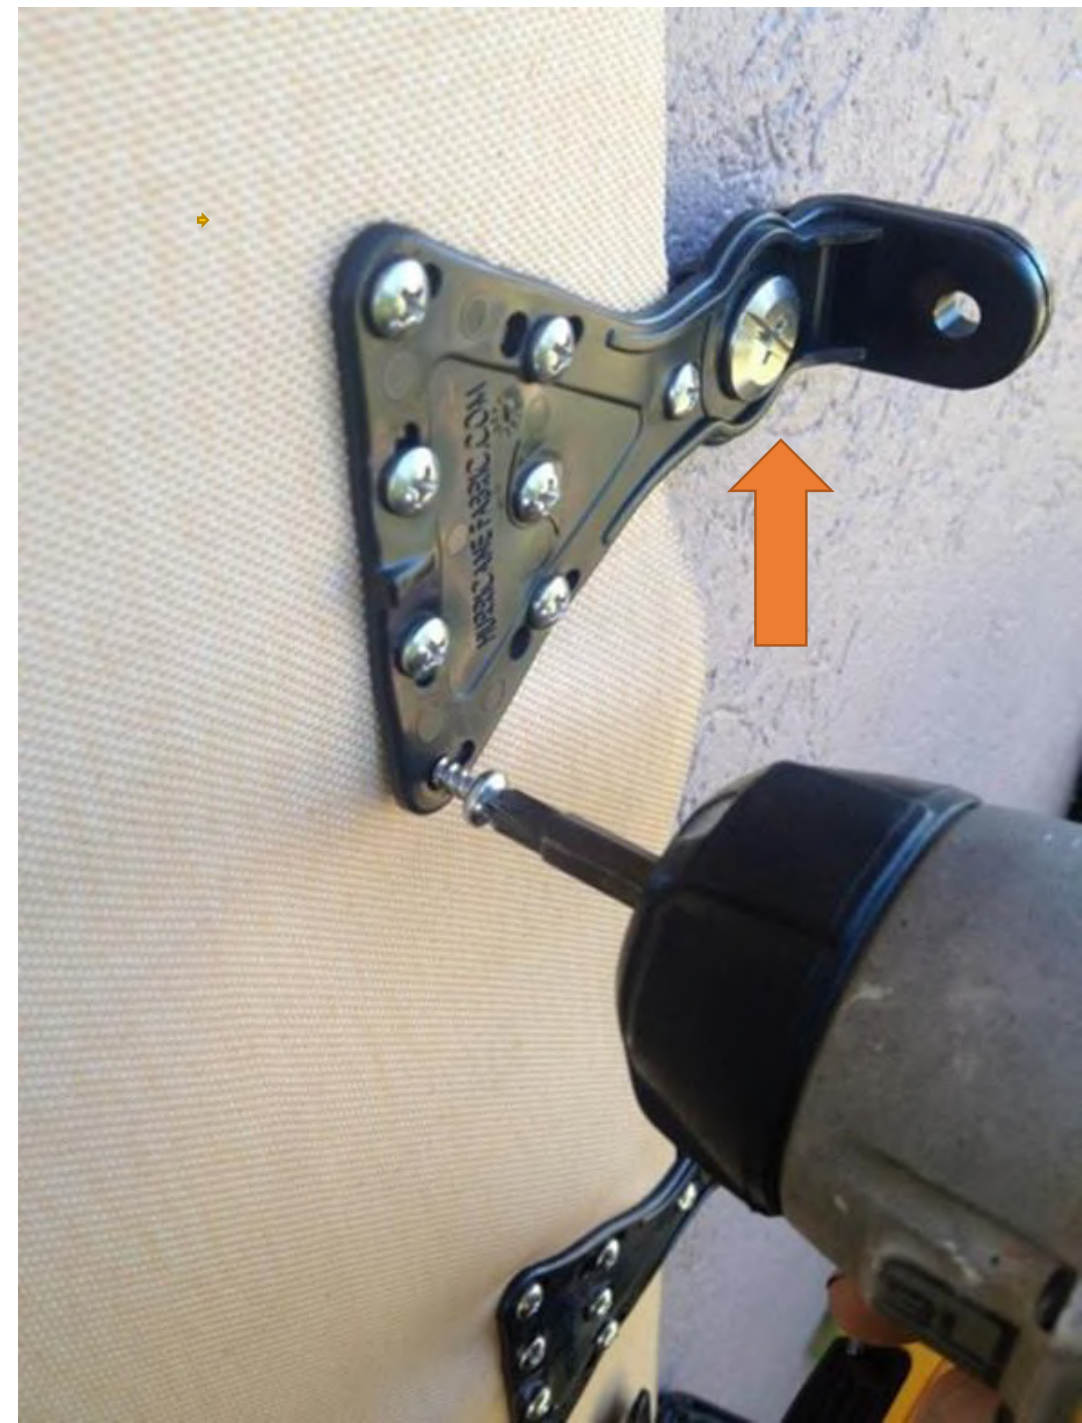
- Clips usually attached to the frames and walls through the flat area of the clips
  - Similar to the image shown
  - The foot plate is the 90 degree base with the hole
- This arrangement does not expose the screw to the rotational forces
