# AstroGuard and Cyclone Winston Performance report

Cyclone Protection Australia

# Review of 2 properties protected by AstroGuard during Tropical Cyclone Winston

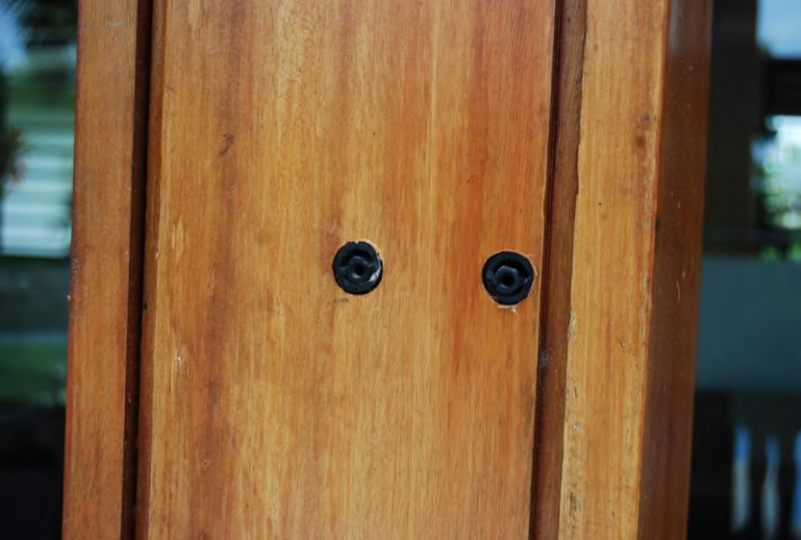
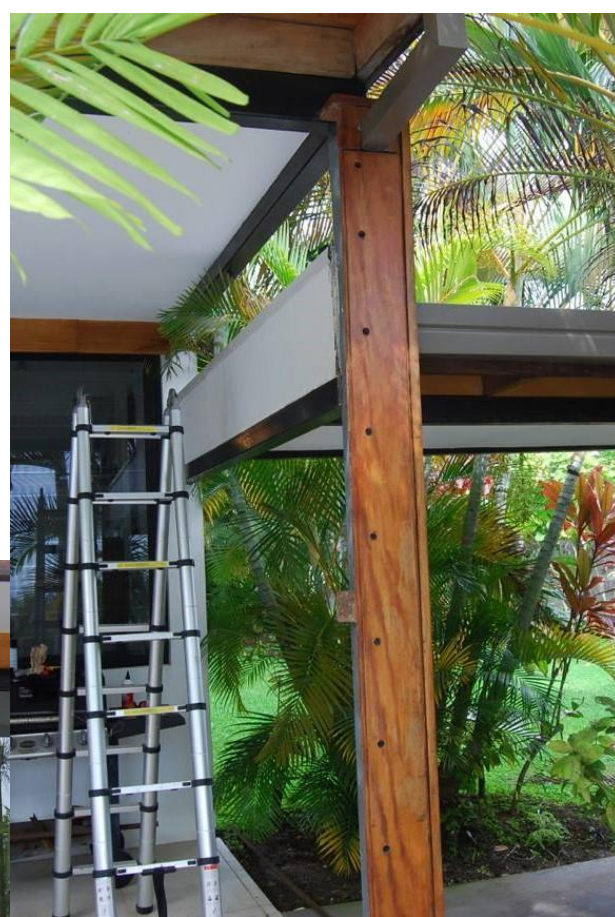
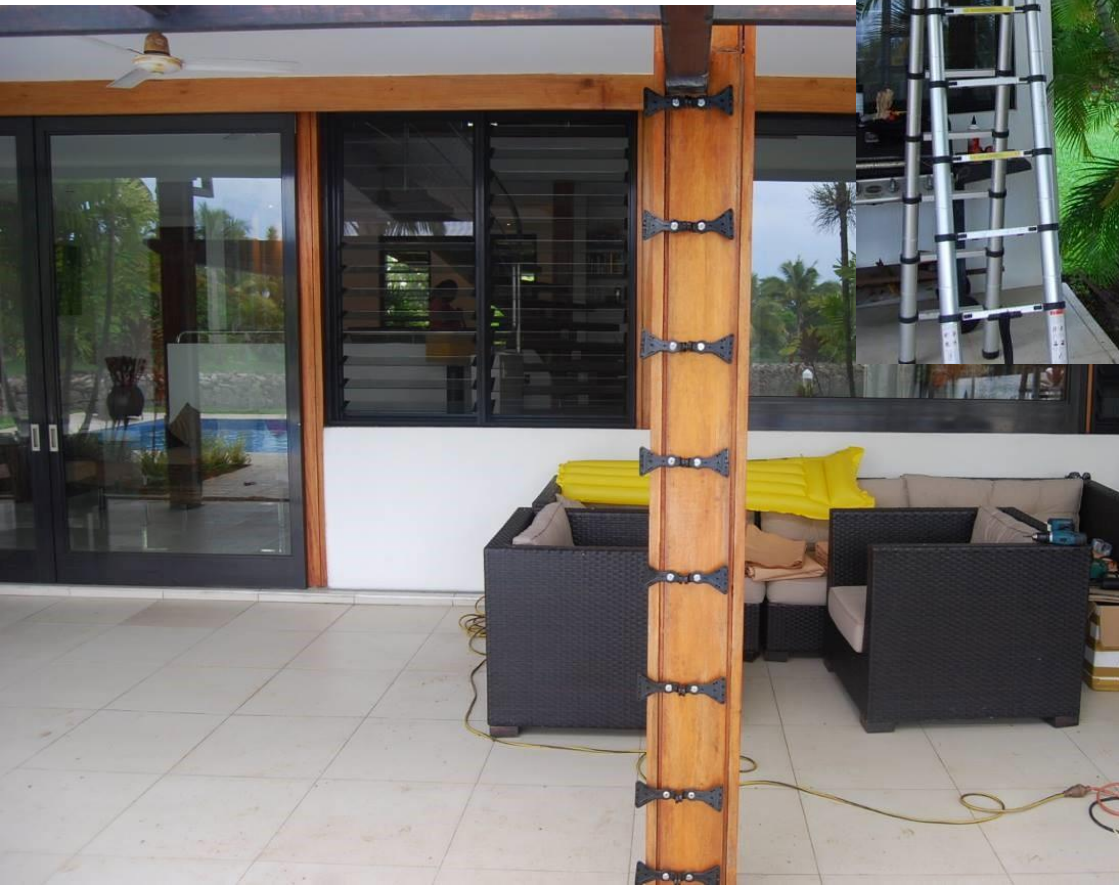
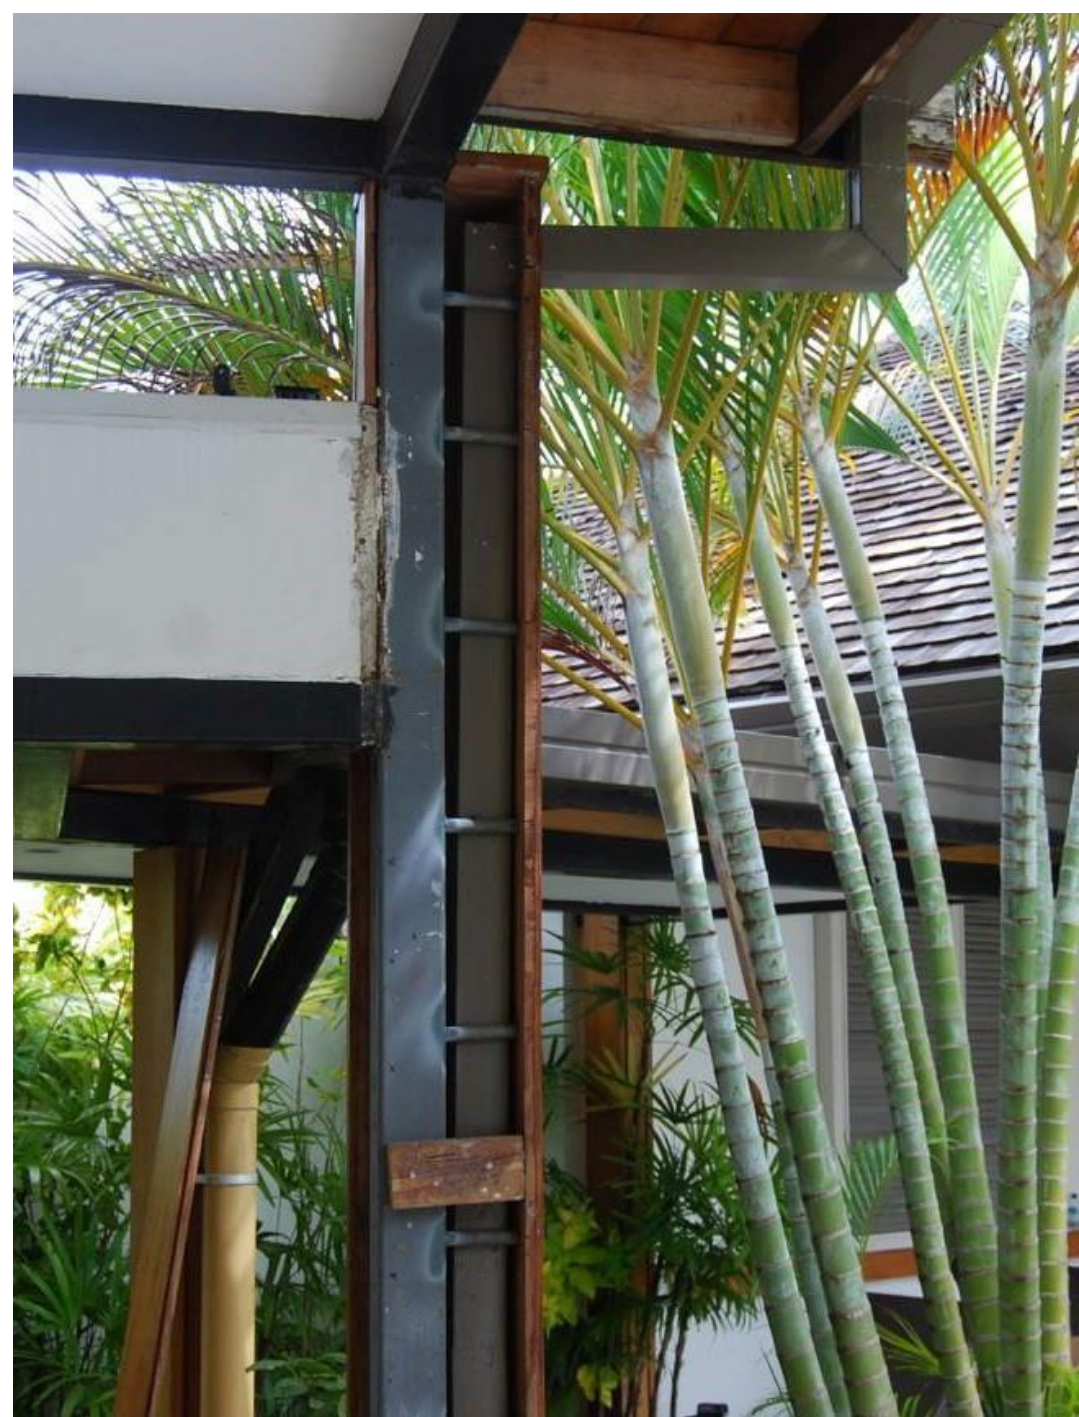
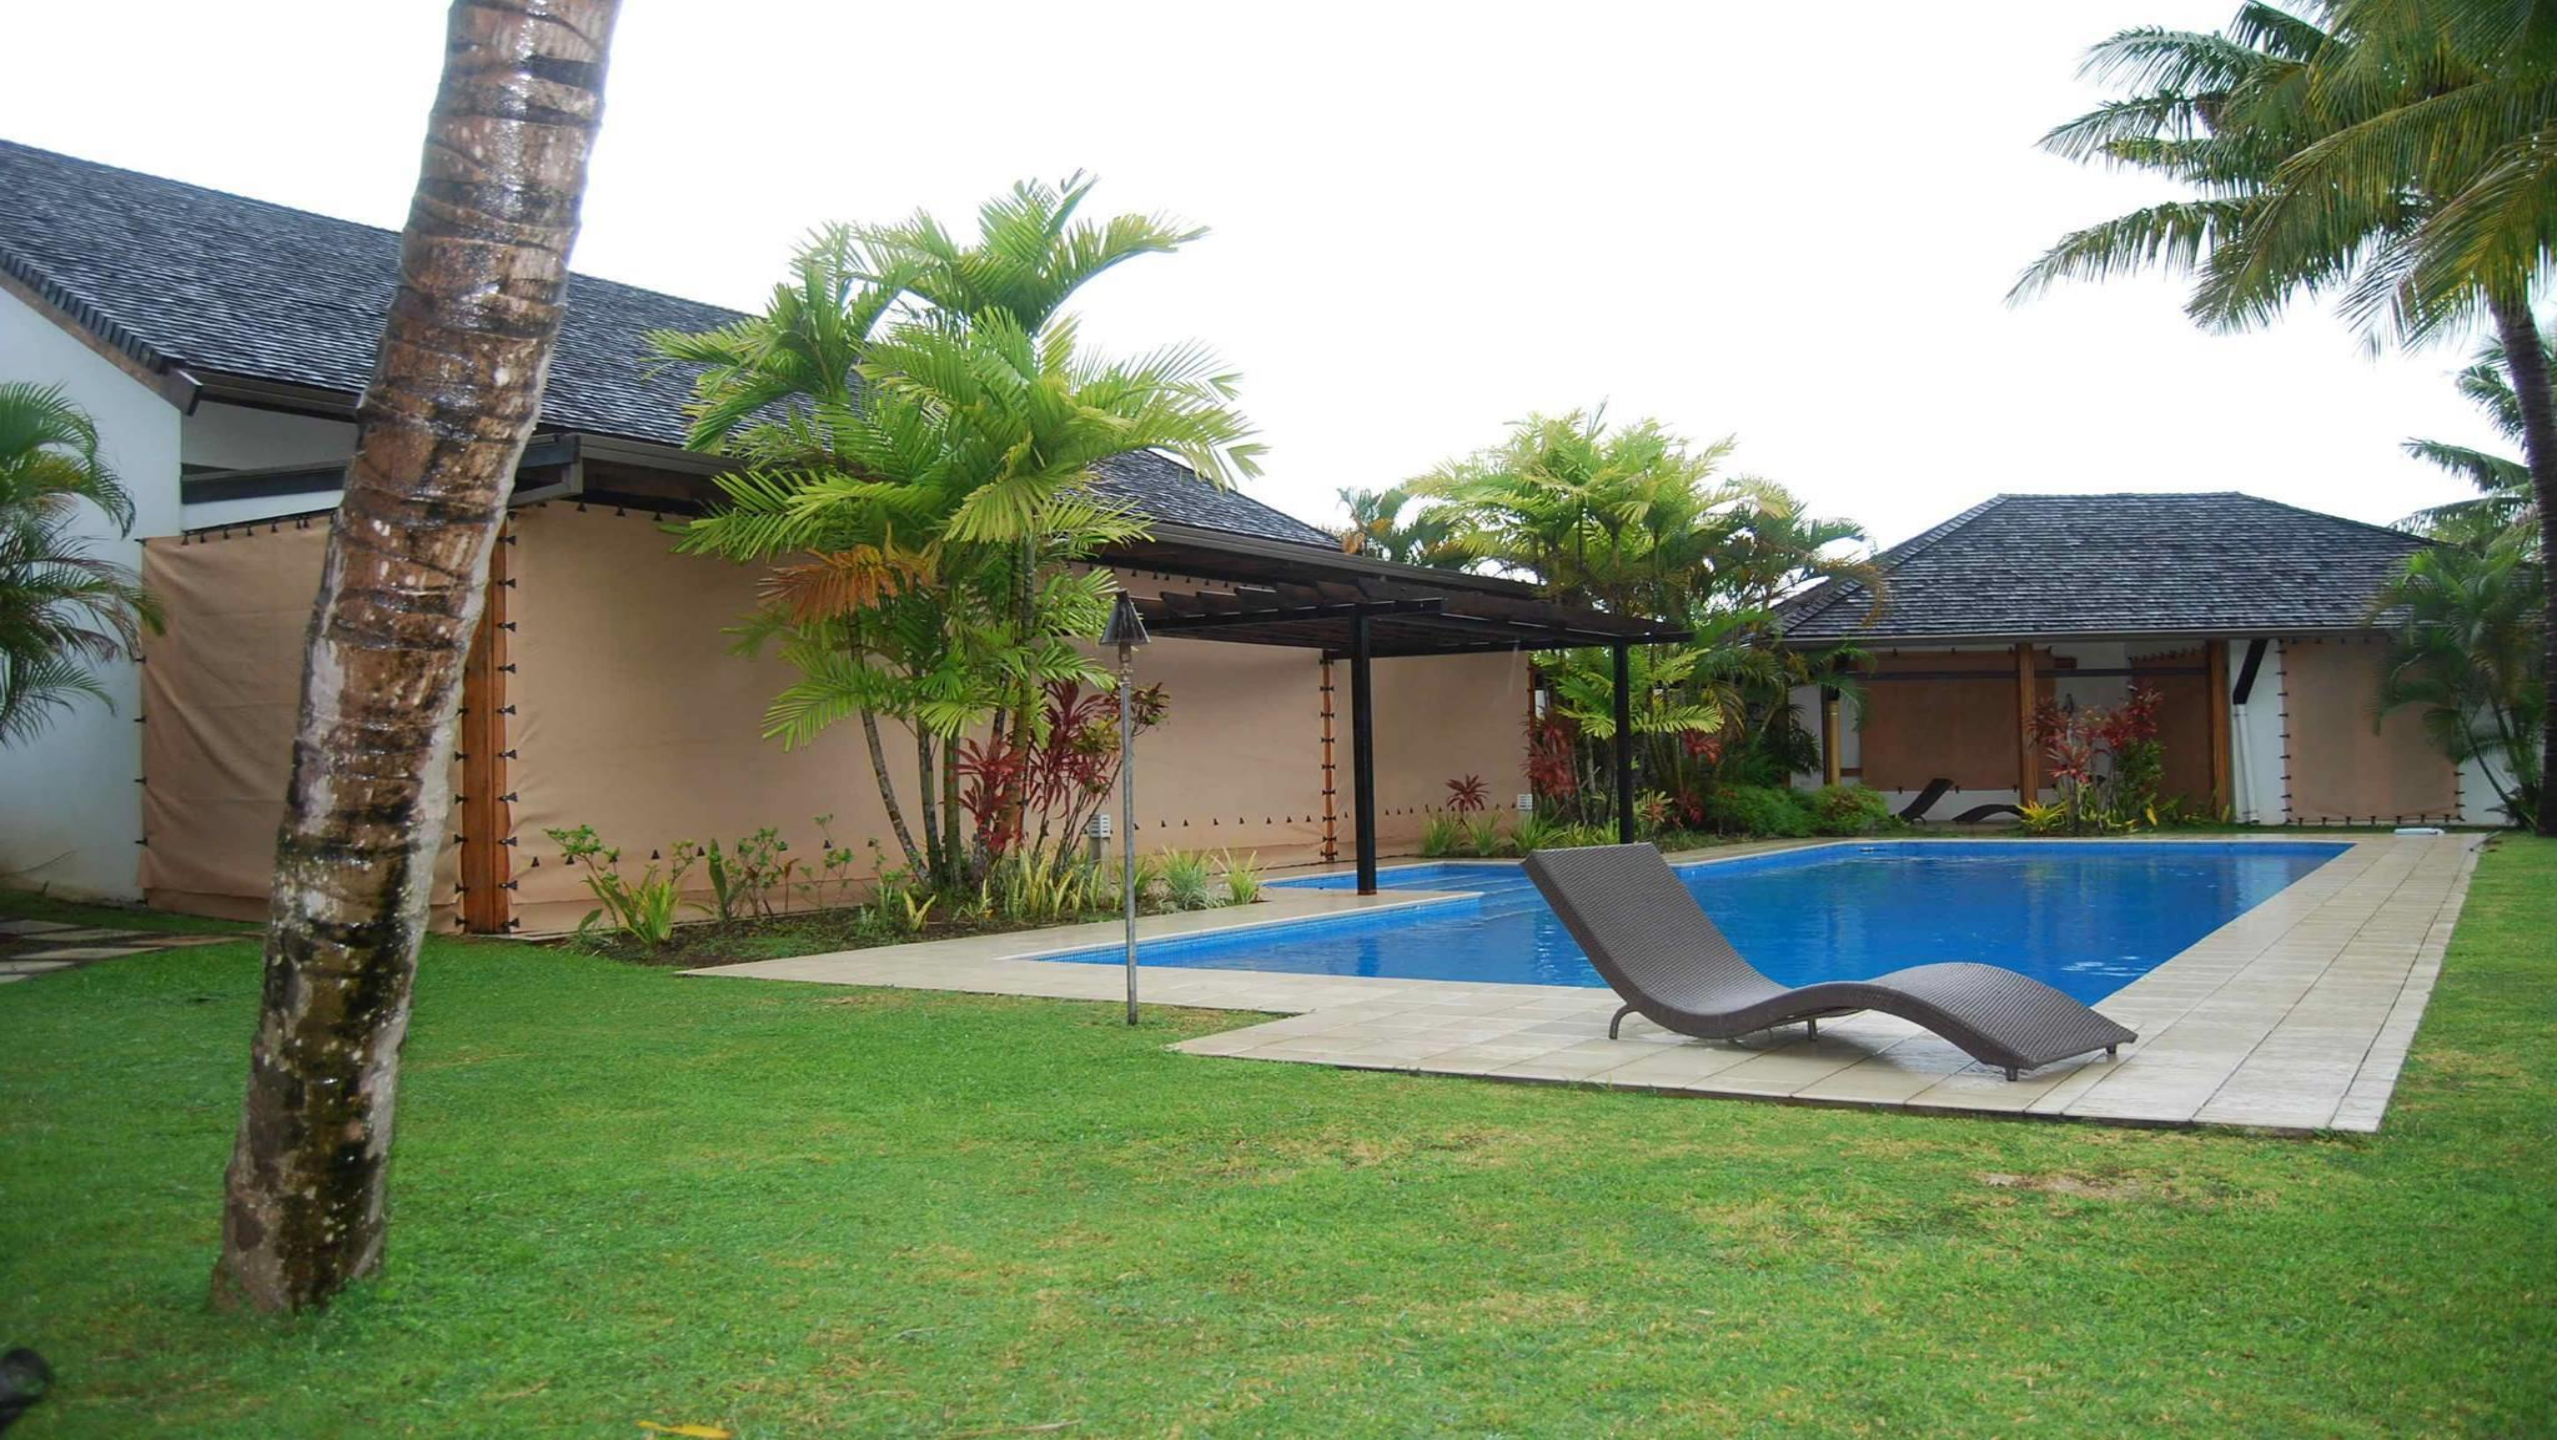
- Large home
- Owners live abroad
- Central entertaining area
  - Large spans of AstroGuard attached around the patio area
  - Flat attachment of clips to concrete, additional metal attachments welded into cladded columns around the patio, 90 degree attachments into tiled concrete floor

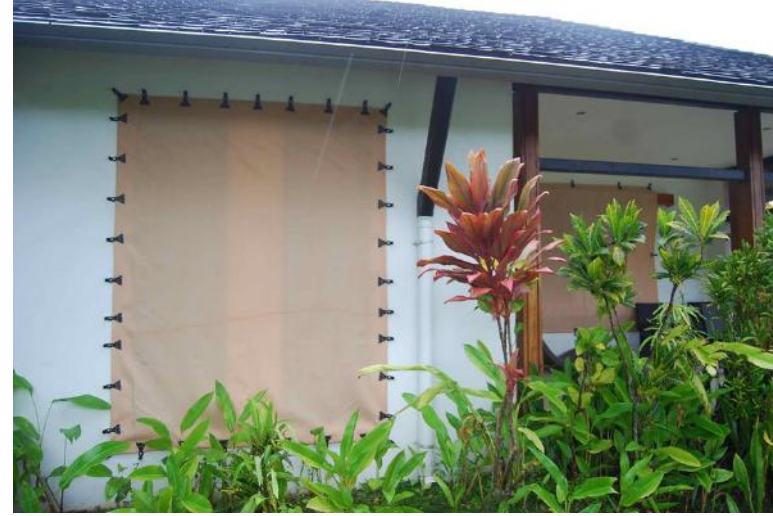
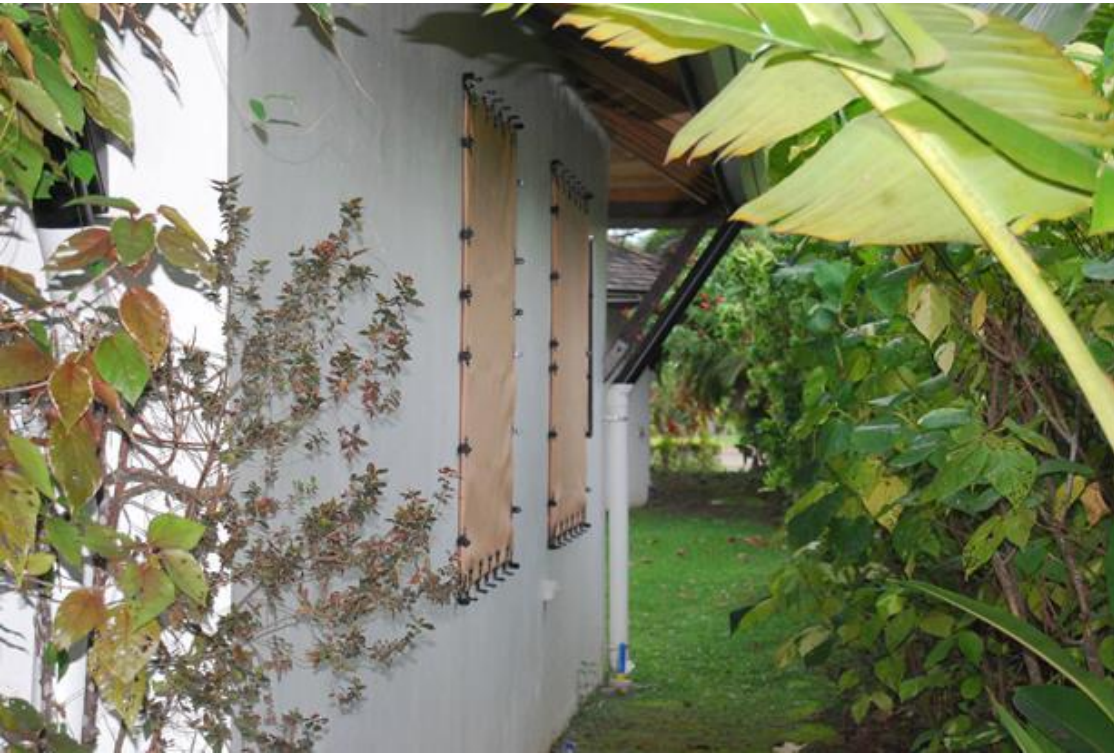
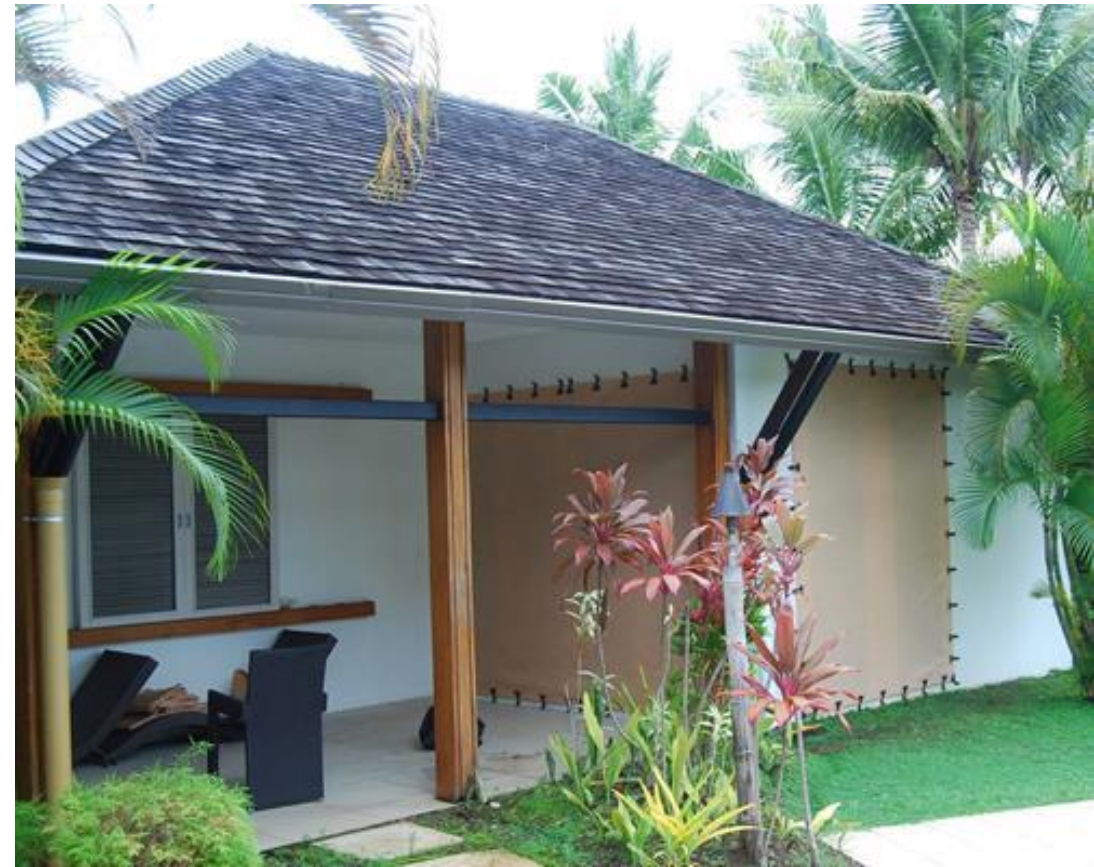
- Standard attachment of variety of sized fabric sections covering doors and windows

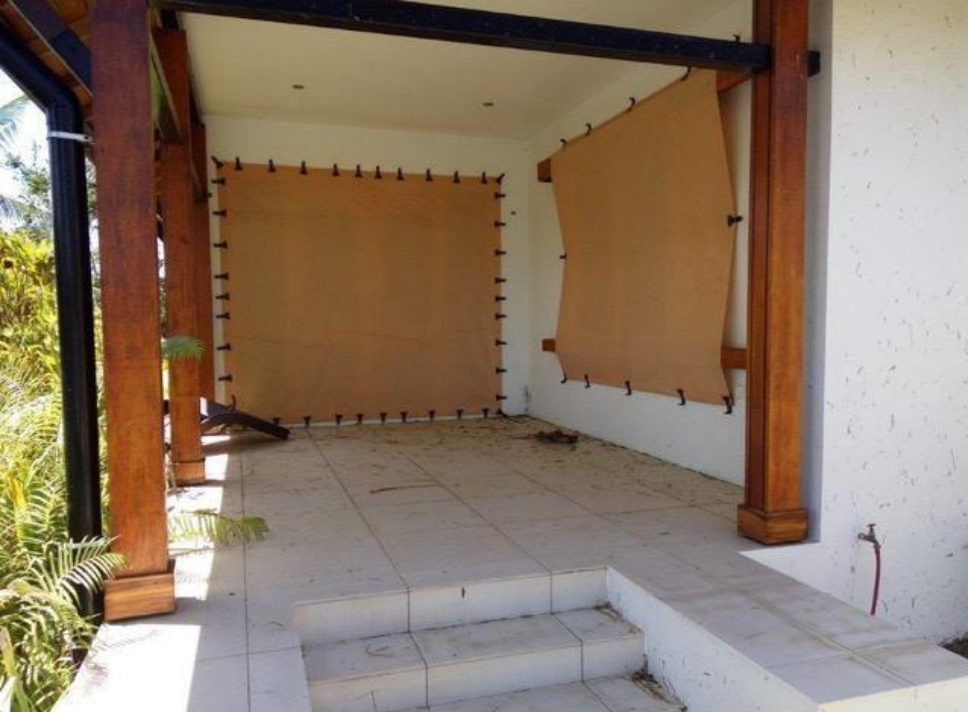
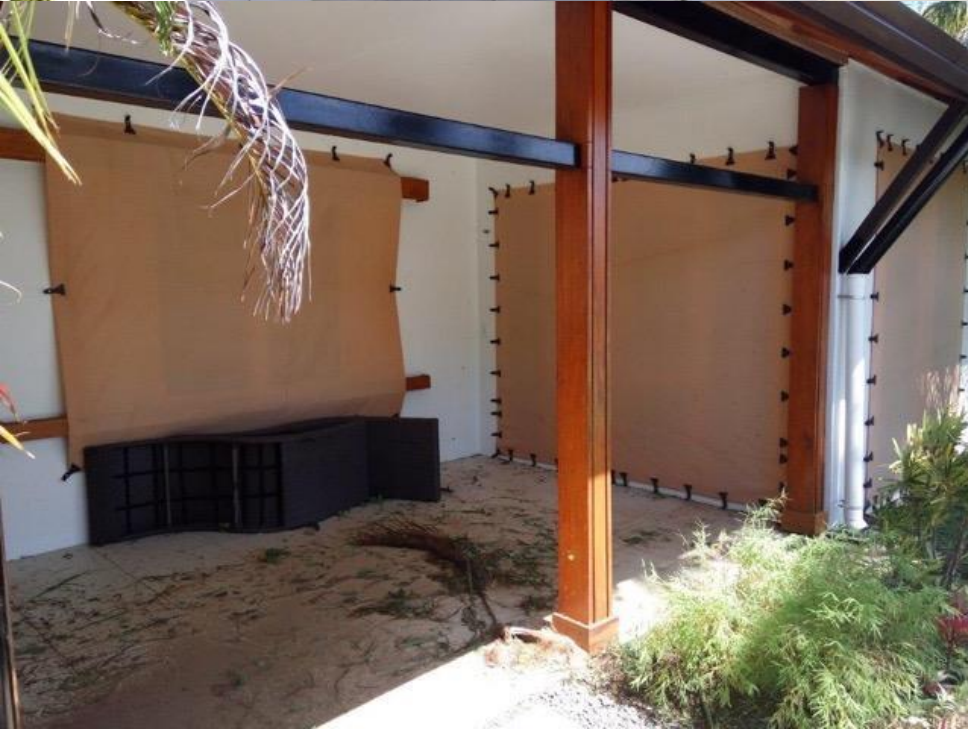
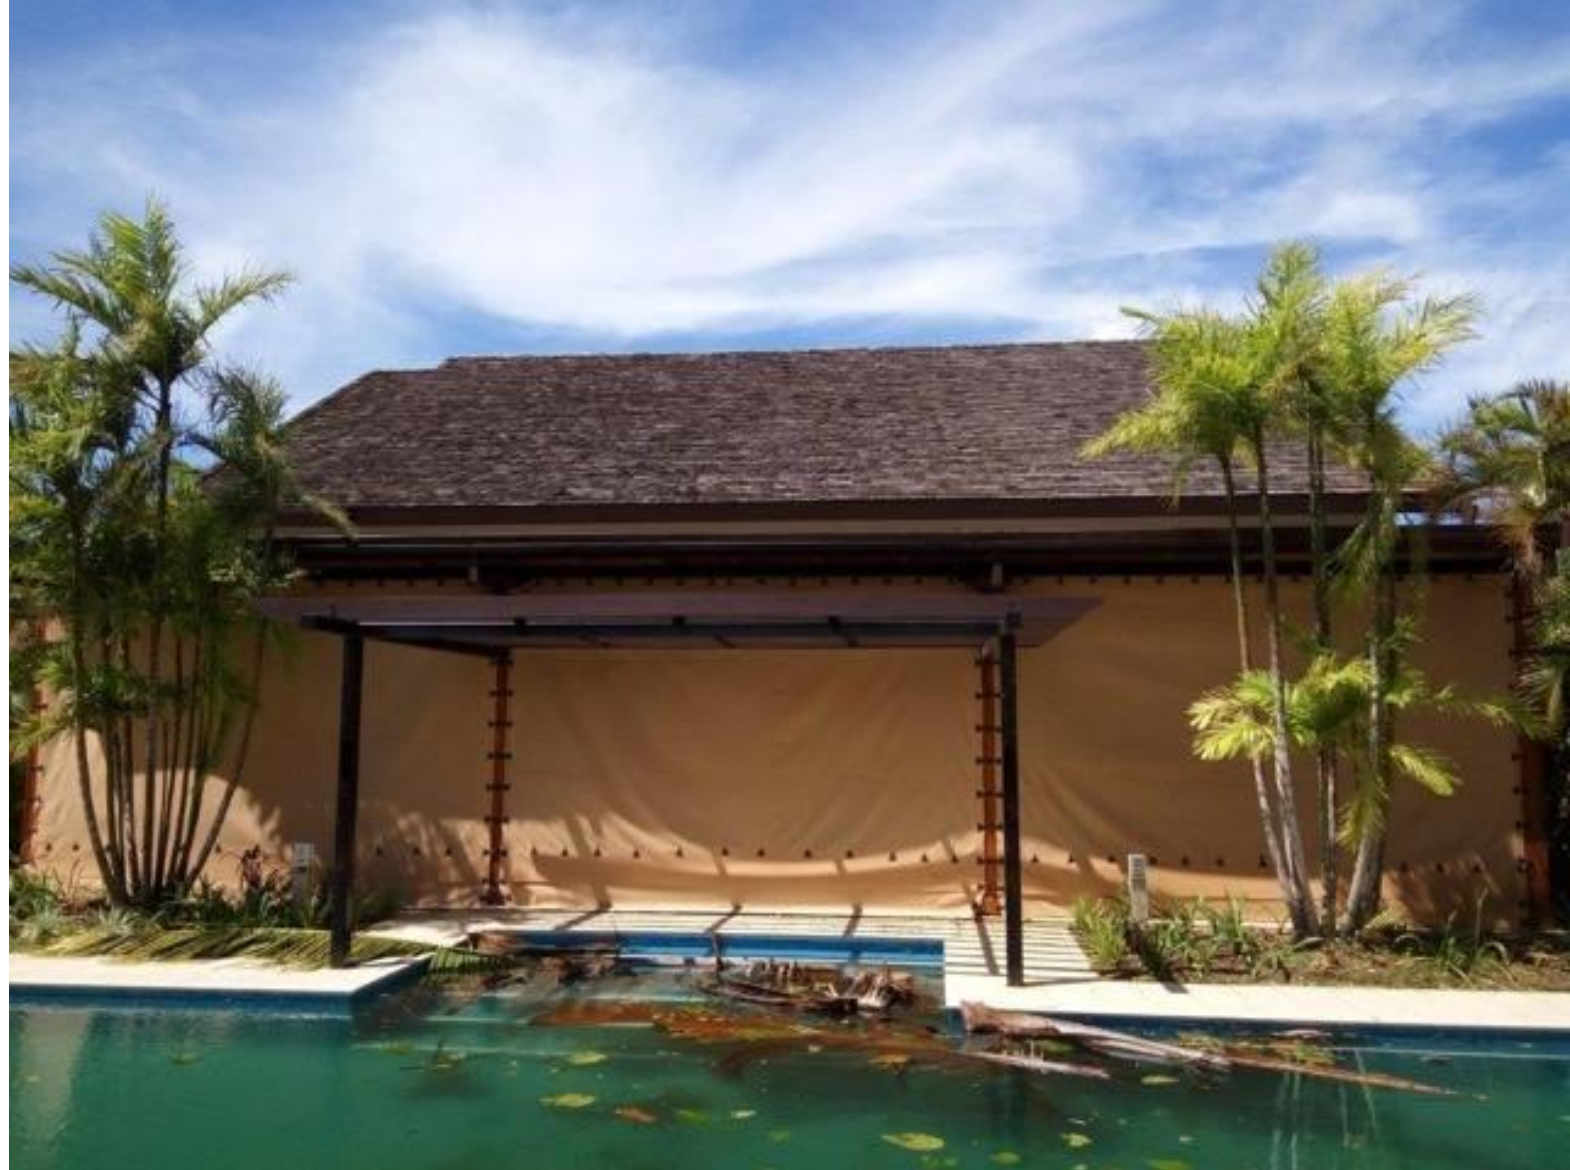
- No damage
- System performed without incident
- Welded attachment on metal posts around patio performed without issues
- Some sagging of some of the larger sheets
  - Allow to dry out with sun exposure
  - May shrink back
  - If not clips can be repositioned with ease
