**CYCLONE TESTING STATION**  
**COLLEGE of SCIENCE, TECHNOLOGY and ENGINEERING**  
**James Cook University**

**REPORT NO. TS969**

**Simulated Windborne Debris Impact Testing of Astroguard  
Impact Protection Screen Assembly System**

**Cyclone Protection Australia**

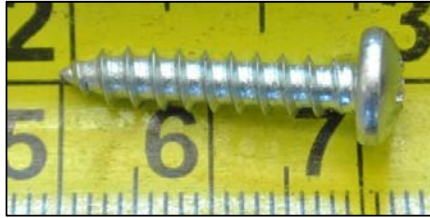
**Figure 4:** Typical clip fastener

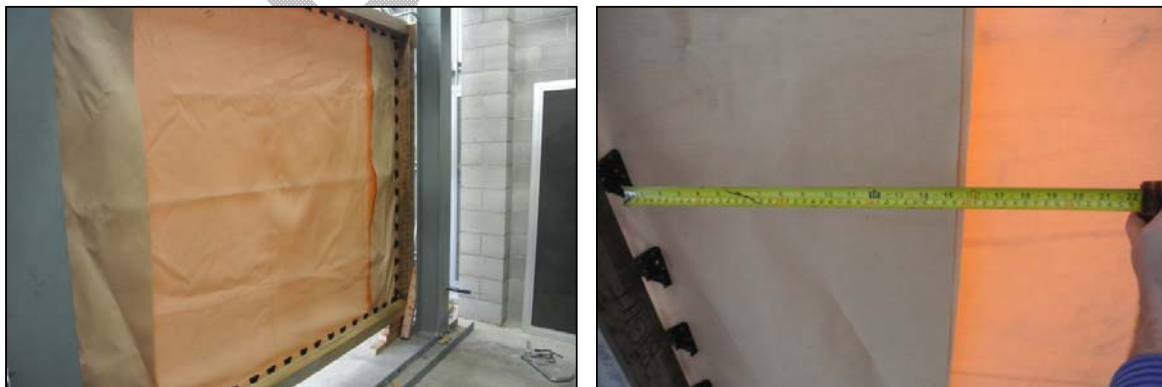
**Figure 6:** Test setup showing multilayer fabric (left) and underlapped section of fabric (right)

Each specimen was installed with three (3) layers of *Astroguard* screen fabric and both side edges folded over creating an underlapped section. The underlapped section extended approximately 400 mm from each side edge toward the centre of the screen. Figure 6 shows the test specimen setup with multilayer fabric and underlapped section.

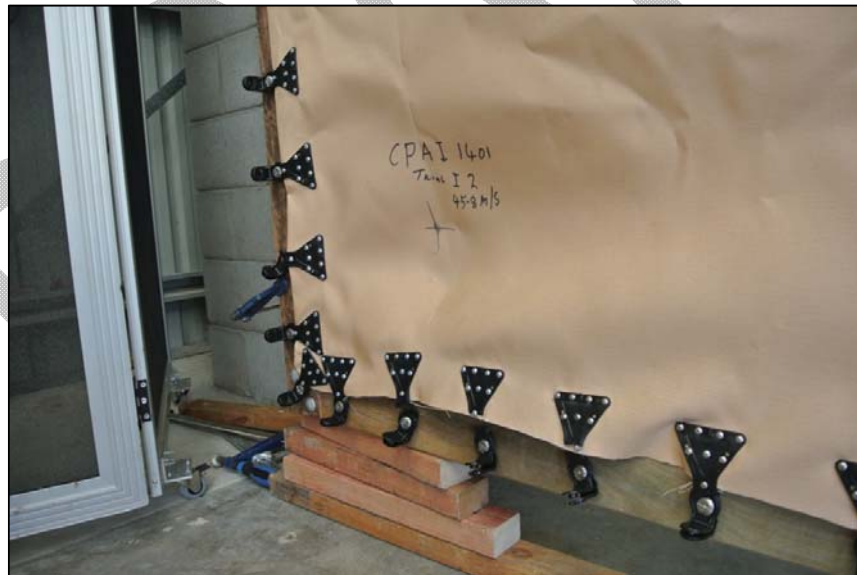
**Figure 8:** General view of impacted area

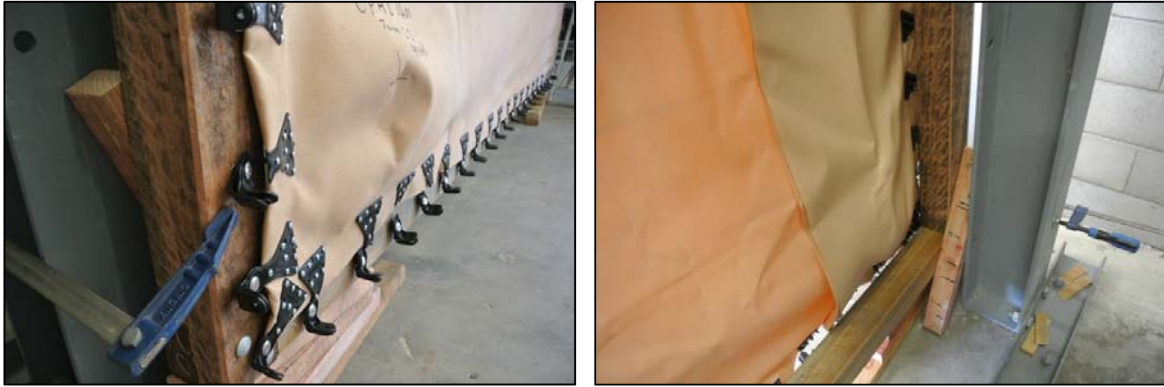
**Figure 9:** Detail view of impacted area; front view (left) and rear view (right). Note no opening created as corner clips and adjacent clips remain undamaged.

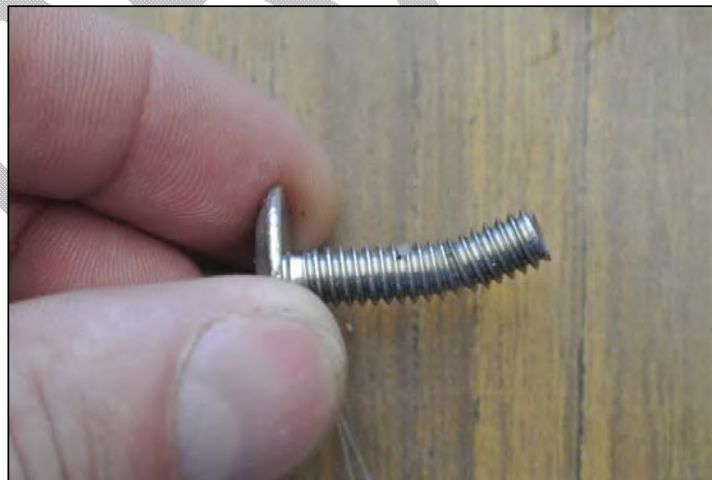
**Figure 11:** Typical bent anchor screw

Test No.	Date Tested	Impact Location	Measured Impact Velocity (m/s)	Results and Observations
I1	18 Aug 2014	Geometric centre	45.4	<b>Pass.</b> No penetration of fabric. All clips remained intact and undamaged. No visible damage to specimen. On inspection after removal of test specimen some anchor screws had been bent.
I2		Corner	45.8	<b>Pass.</b> No penetration of fabric. Four clips broke off at connection, but corner clips remained intact with no opening created. On inspection after removal of test specimen some anchor screws had been bent.
I3a-e		Various (five in total)	52.6, 54.9, 55.5, 55.5, 52.0	<b>Pass.</b> No penetration and no visible damage.
