ADDENDUM TO REPORT NO. TS868

17 June 2014

**Simulated Windborne Debris Impact Testing of Astroguard
Impact Protection Screen Assembly System**

Cyclone Protection Australia

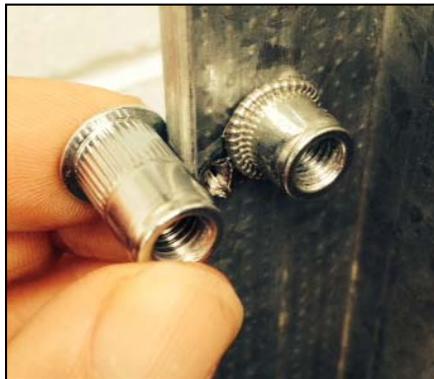
Figure 11: Photograph of two threaded hollow rivets used in the steel support frame, one prior to installation and the other installed into the steel support

The support frame used for Trial I5 comprised a nominally 1800 × 2100 mm rectangular frame, with a 1200 × 1500 mm inner rectangular section, made from 92 × 34 mm steel C-channels with a total coated thickness (TCT) measuring 0.55 mm. The frame had threaded hollow rivets pre-installed on the outermost rectangular segment with 300 mm centres starting at each corner to allow the clips to be screwed to the frame.

A typical threaded hollow rivet used in the steel frame support for Trial I5 is shown in Figure 11.

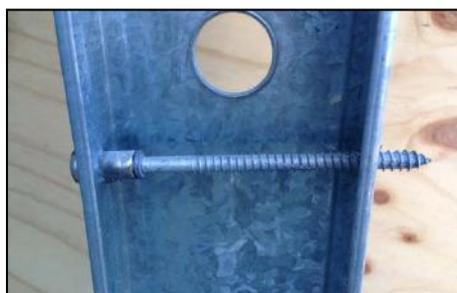
Figure 12: Photograph of a threaded screw anchor installed into the C-channel of the steel support frame for Trial I6

The support frame used for Trial I6 comprised a nominally 1800 × 2100 mm rectangular frame, with a 1200 × 1500 mm inner rectangular segment, made from 92 × 34 mm steel C-channels with a TCT measuring 0.55 mm. The frame had threaded screw anchors pre-installed on the inner rectangular segment with 300 mm centres starting at each corner to allow the clips to be screwed to the frame.

A typical threaded screw anchor installed in the C-channel of the steel frame support for Trial I6 is shown in Figure 12.

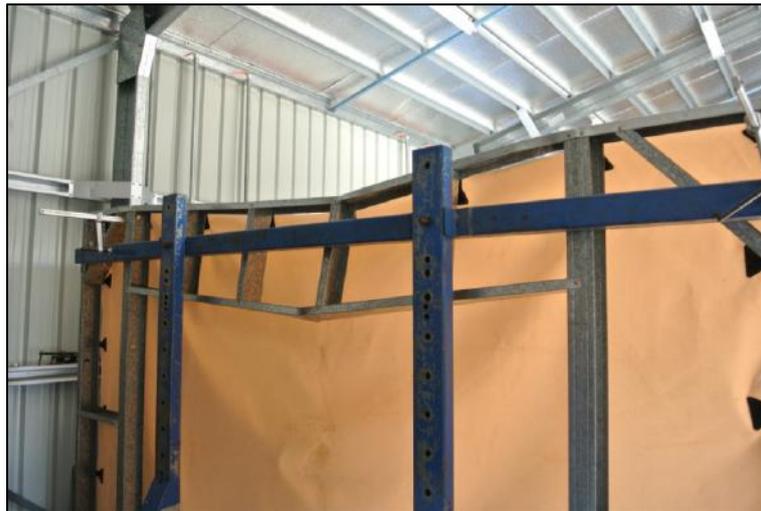
Figure 13: General view of deformation to steel support frame after Trial I5

Test No.	Date Tested	Impact Location	Measured Impact Velocity (m/s)	Results and Observations
I5	3 Jul 2013	Geometric Centre	28.1	Pass. No penetration. Permanent deformation of support frame.
I6			18.9	Pass. No penetration. Permanent deformation of support frame.
I7			28.4	Pass. No penetration. Permanent deformation of support frame.
I8			28.6	Pass. No penetration. Permanent deformation of support frame.

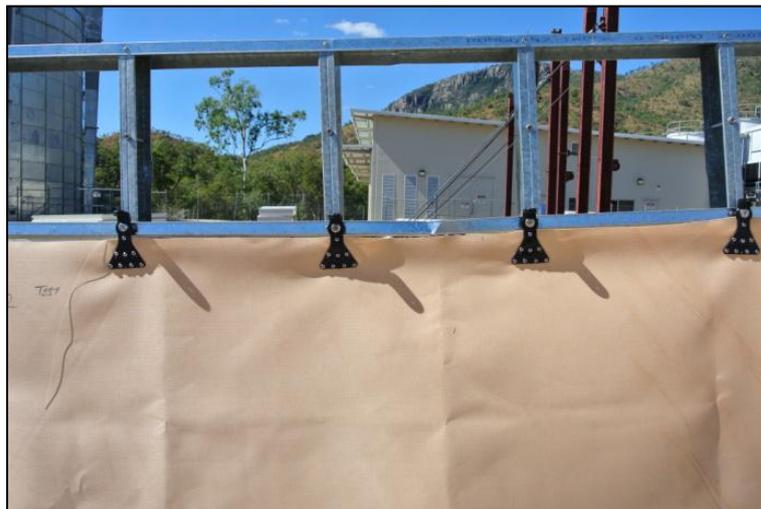
Figure 14: View of deformation to steel support frame after Trial I6

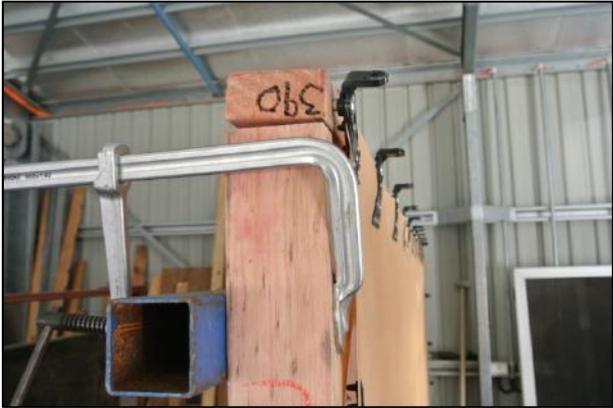
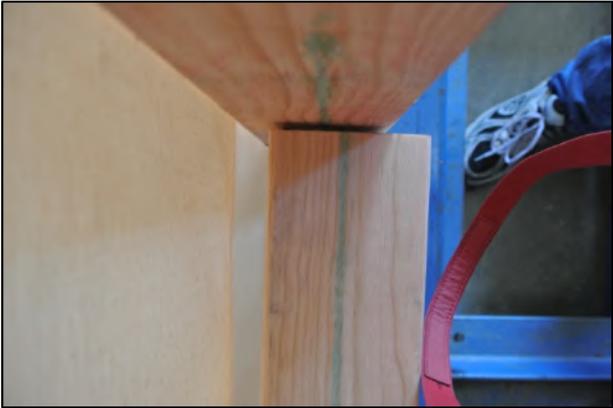
Figure 15: View of deformation to top of timer support frame (left) and side of timber support frame (right) after Trial I7

The support frames used for Trials I7 and I8 comprised 2100 × 3000 mm rectangular frames made from 90 × 45 mm timber. The frames had threaded screw anchors pre-installed with 300 mm centres starting at each corner to allow the clips to be screwed to the frame.

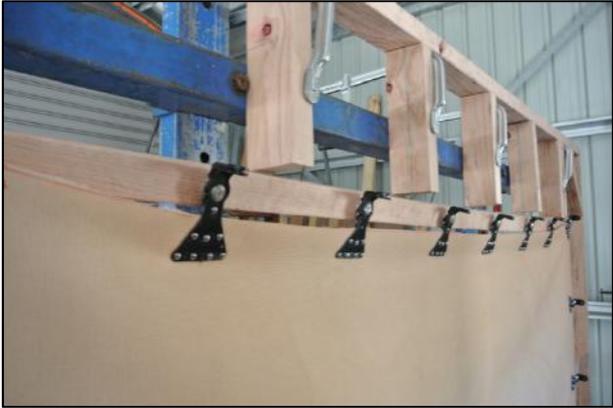
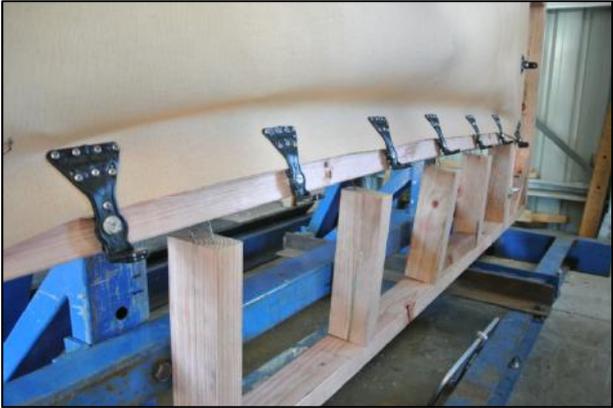
Figure 16: View of deformation to top of timer support frame (left) and bottom of timber support frame (right) after Trial I8
